A Nuclear Power Plant as Launch Pad

Analysis of the occupation of Zaporizhzhia NPP
by Russian armed forces and Rosatom and
the role of the IAEA

**Analysis of the Russian Seizure
and Ongoing Occupation of the
Zaporizhzhia Nuclear Power Plant (ZNPP)**

September 2023

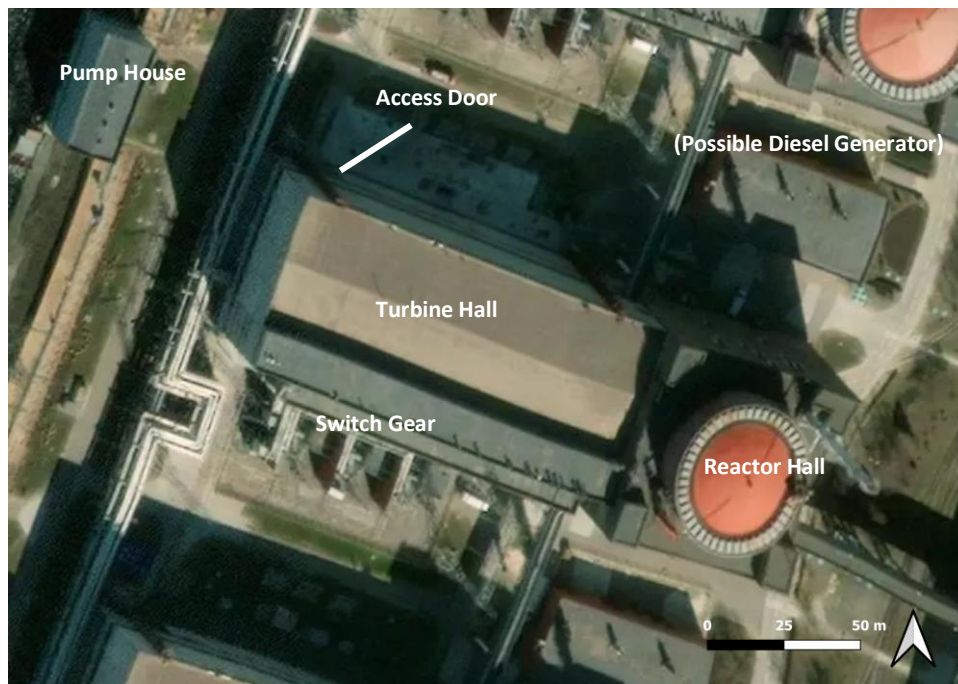
Fig. 3 – Reactor and Turbine Unit Layout

Each reactor and turbine hall unit is constructed along similar lines (Fig. 3). The reactor hall which is easily identifiable by the red roof of the containment building is located at the eastern end of each unit. The turbine hall is directly connected to the western side of the reactor hall. Switch gear connecting the turbine hall to the transformer yard is external to the hall and positioned along the southern side of the turbine hall. A large access door is located at the rear of the turbine hall on the northern side of the building. Each unit is also served by a pump house to the rear of the turbine hall and alongside the canal leading from the large cooling pond. Each unit also has an associated external building adjacent to the northern side of the reactor hall. The precise purpose of this building cannot be ascertained by imagery but research suggests it may house an emergency diesel generator to provide power to the unit. An extensive network of pipes runs along the western edge of the units parallel with a service road that separates the units from their associated pump house. An area of open ground separates each unit with an approximate distance of 91m between each unit. The areas of open ground between the units were often used for storage unidentified objects and vehicles over the reporting period. It is not clear what the items may have been but the vehicles that were parked in these areas were not armoured military vehicles or weapon systems. A local rail network runs along the eastern end of the units with a line leading into the reactor halls. The possible emergency generator halls to the east of the units are also connected to each of the units via a raised structure, most likely containing pipes or power lines to the reactor halls.

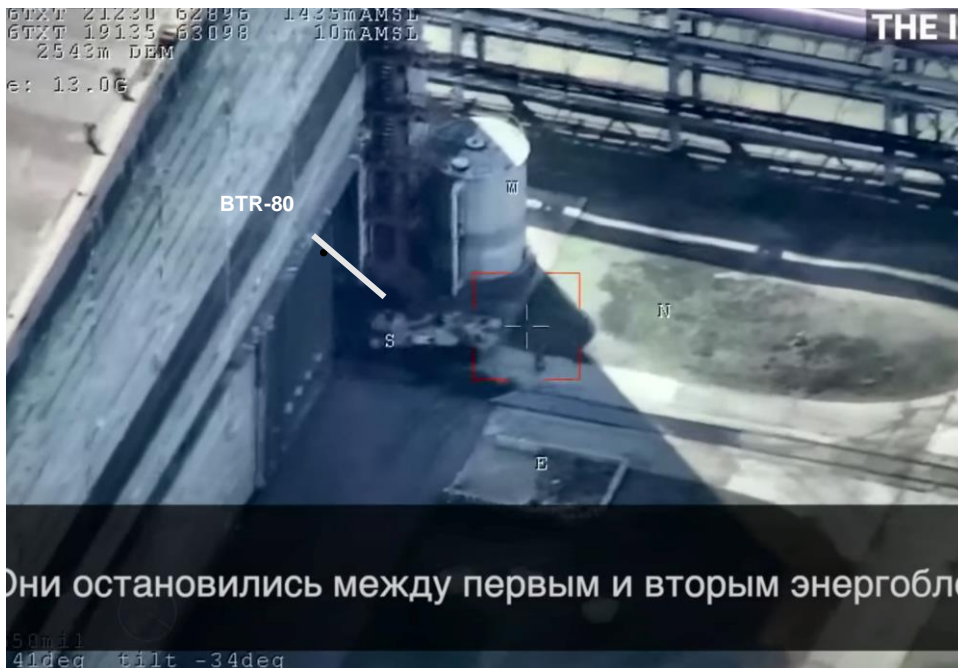
Fig. 4 – BTR-80 APC Entering Turbine Hall (The Insider dated 5 Aug 2022)

At 08:37hrs the large doors to the turbine halls of reactors 4 and 5 were partially opened (Fig. 13). The doors were not open sufficiently to allow vehicular ingress/egress but indicates that some activity was ongoing which required access to the rear of the turbine halls. The door to the turbine hall of reactor 1 was fully open although no vehicular activity was observed. No other vehicular activity was observed around the plant on both imagery collections. Other reporting from CNN and The Insider, both from August 2022 confirm the presence of vehicles inside the turbine halls (Fig. 5). Footage from a UAV of the plant, published on 5 August 2022 identifies utility trucks and BTR-80 armoured personnel carriers entering the turbine hall of reactor 1 (Fig. 4).

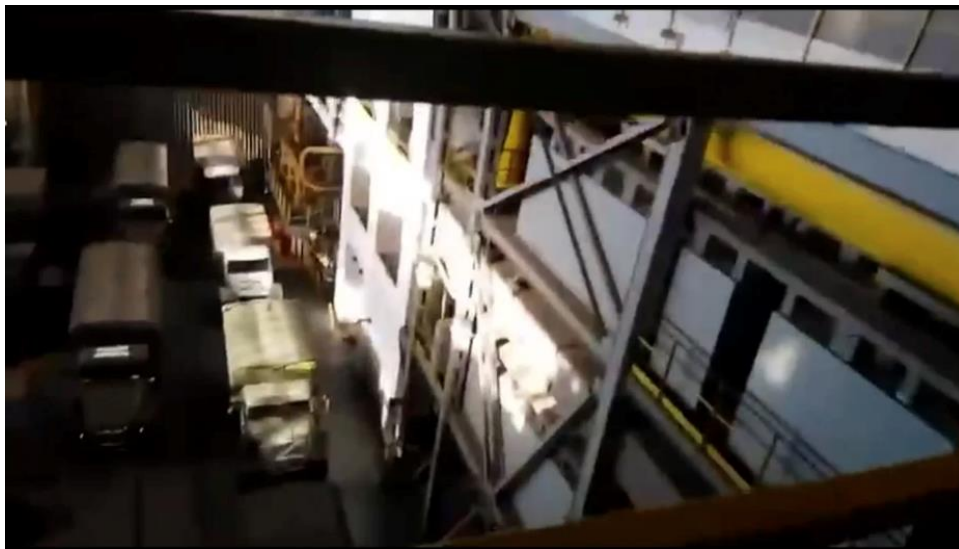
Fig. 5 – Utility Trucks Parked Inside Turbine Hall (CNN 'Russian vehicles seen inside turbine hall at Ukraine nuclear plant' dated 19 August 2022)

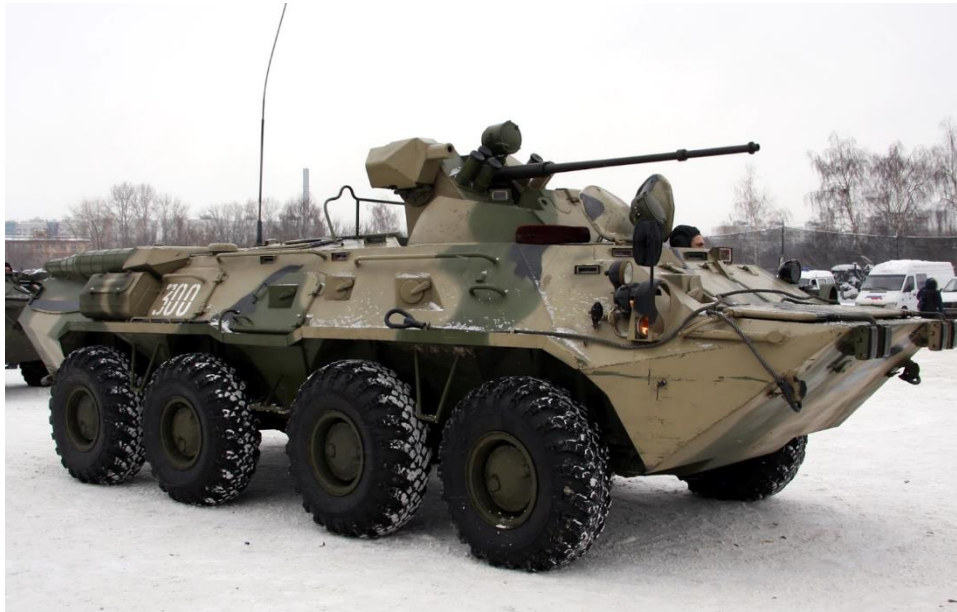
Fig. 6 – BTR-80 Armoured Personnel Carrier (Wikimedia Commons)

The Russian National Guard is a separate force from the Ministry of Defence and do not come under the command of the Chief of the Defence Staff or Defence Minister. As an agency it reports directly to the President of Russia and has a stated mission of security of the national border, counter terrorism and guarding of essential national facilities. The specific capabilities and functioning of the Russian National Guard is consistent with their presence at the power plant. The force is equipped with heavy vehicles such as the BTR-70 and 80 (Fig. 6) as well as other heavy armoured urban patrol vehicles. These vehicles match those observed at the plant but are not indicative of a specific type of unit; they are standard vehicles that can be found in most units of the Russian ground forces and other security units.

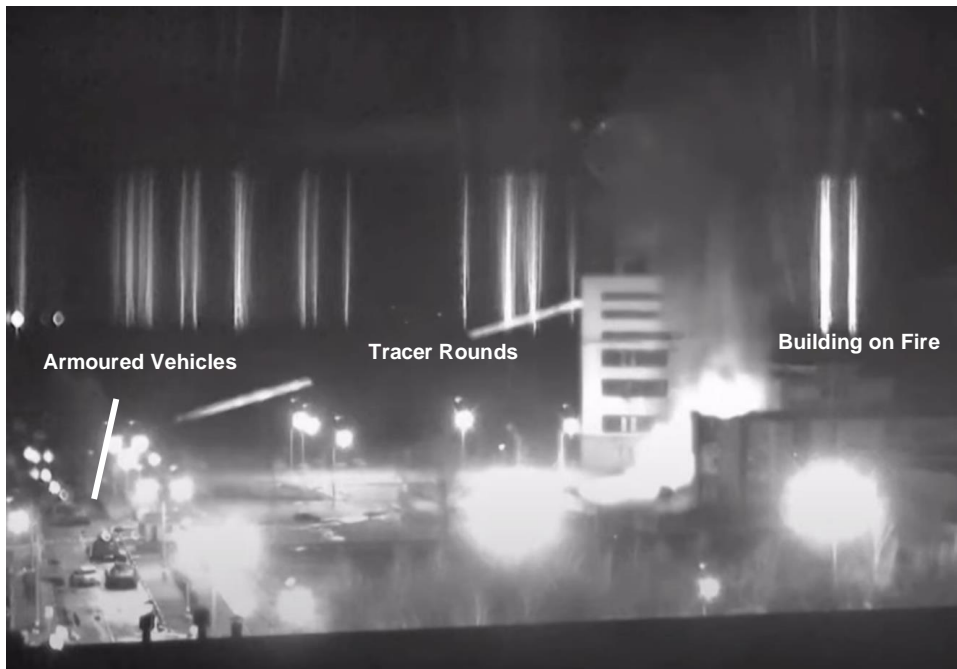
No cloud-free, very high resolution satellite imagery of the plant is available prior to 15 March. CCTV footage has been released on YouTube which presents footage of the assault by the Russian forces on the training building which is located to the immediate south of the plant and external to the secure perimeter (Fig. 7). Directly behind the training building is the ZNPP transformer yard. The footage is of sufficient quality to identify armoured vehicles, likely to be BTR variants firing on the training building, most likely with their turret-mounted 14.5mm machine guns. Tracer rounds can be seen being directed towards and striking the training building. While the tracer fire appears to be sporadic, it must be considered that standard practice is usually a ratio of 1:4 or 5 i.e. 1 tracer round per 4 or 5 standard rounds. A 14.5mm machine gun delivers a significant weight of fire and will have caused extreme damage to the building. Muzzle flashes from the armoured vehicles also indicate fire was being directed onto the building without tracer rounds, possibly from smaller calibre weapons such as 7.62mm. The footage confirms some of the rounds overshot the building or ricocheted behind the building and may have impacted the transformer yard behind the training building.

Fig. 7 – CCTV Footage of Assault on Training Building (YouTube
<https://www.youtube.com/watch?v=pelEvbcb7ec>)

The footage does not indicate the use of heavier weapons such as from a main battle tank (MBT) or indirect fire from mortar or artillery assets although this cannot be ruled out. No return fire was observed from the training building although Russian personnel can be observed taking cover behind the armoured vehicles that are firing on the building. As a result of the assault on the plant, the training building sustained severe damage with a fire burning for a substantial amount of time. A report from the Nuclear Engineering International industry newsletter² dated 13 July 2022 quotes Olexiy Kovynyevis, an independent expert and former reactor operator and shift supervisor, who highlighted the potential for catastrophic damage to safety elements at the plant. Whilst the list of safety infrastructure was described as “almost” impacted, they were not affected by the fighting during the assault.

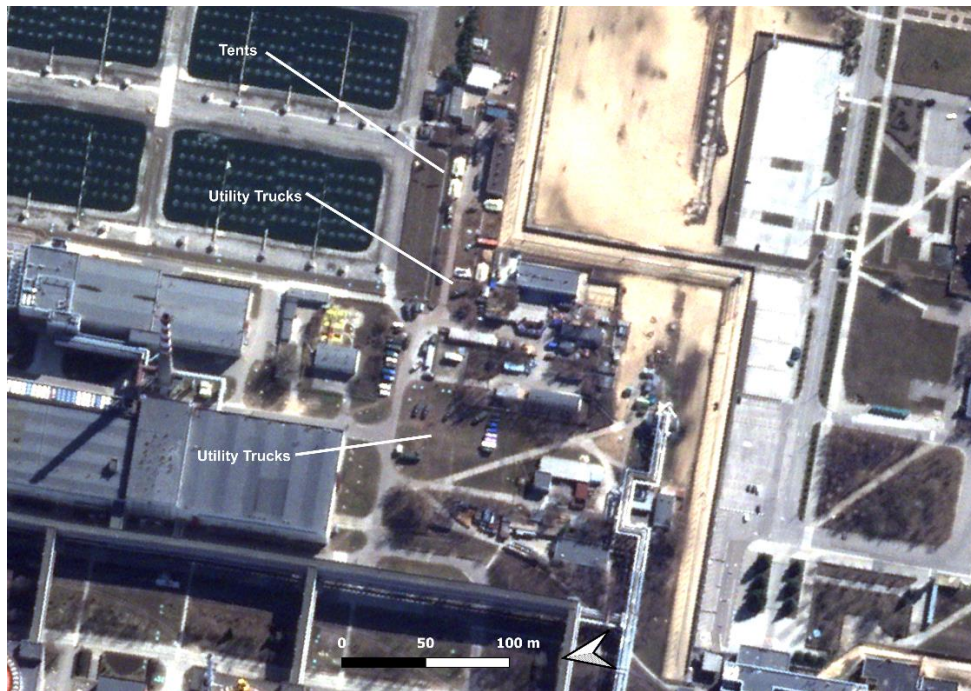
The first available very high resolution imagery after the assault is dated 15 March 2022. The staff car parks for the plant are empty, suggesting a low number of plant operating personnel were present at the plant. A number of utility trucks were observed on an area of open ground to the south of the spray ponds within the secure perimeter although not the amount of vehicles that would be expected to be seen for a battalion sized unit (Fig. 8). A number of tents had been erected in the same area.

Fig. 8 – Utility Trucks and Tents Erected within Plant Compound

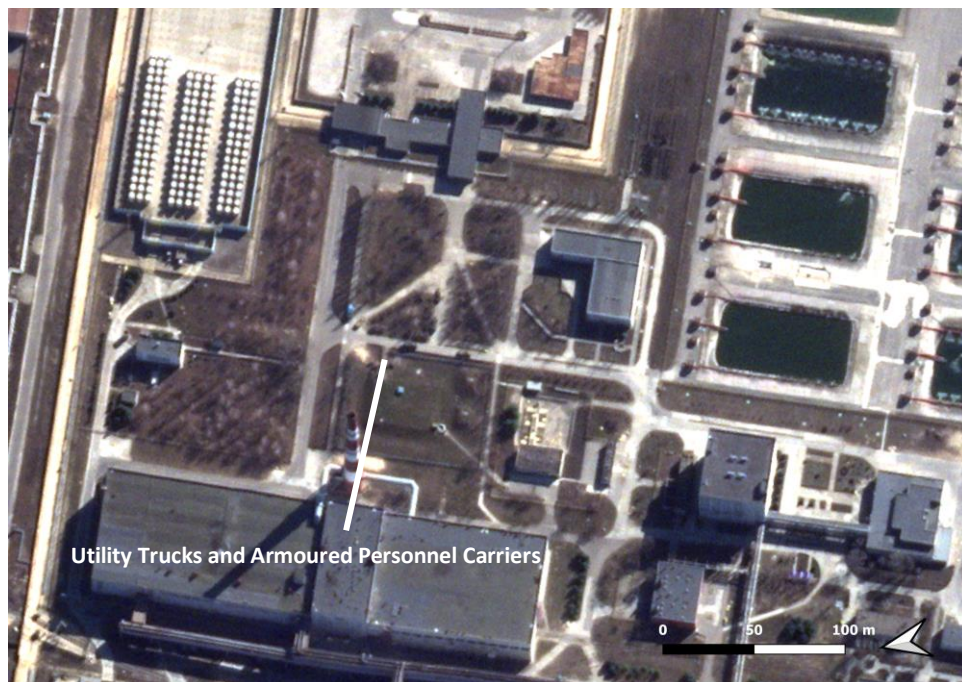
A small number of vehicles were also observed in the northern part of the secure compound adjacent to the northern entrance. Cross referencing with imagery on Google Earth dated April 2022 confirms these vehicles as utility trucks and BTR-80 armoured personnel carriers (Fig. 9).

Fig. 9 – Utility Trucks and Armoured Personnel Carriers

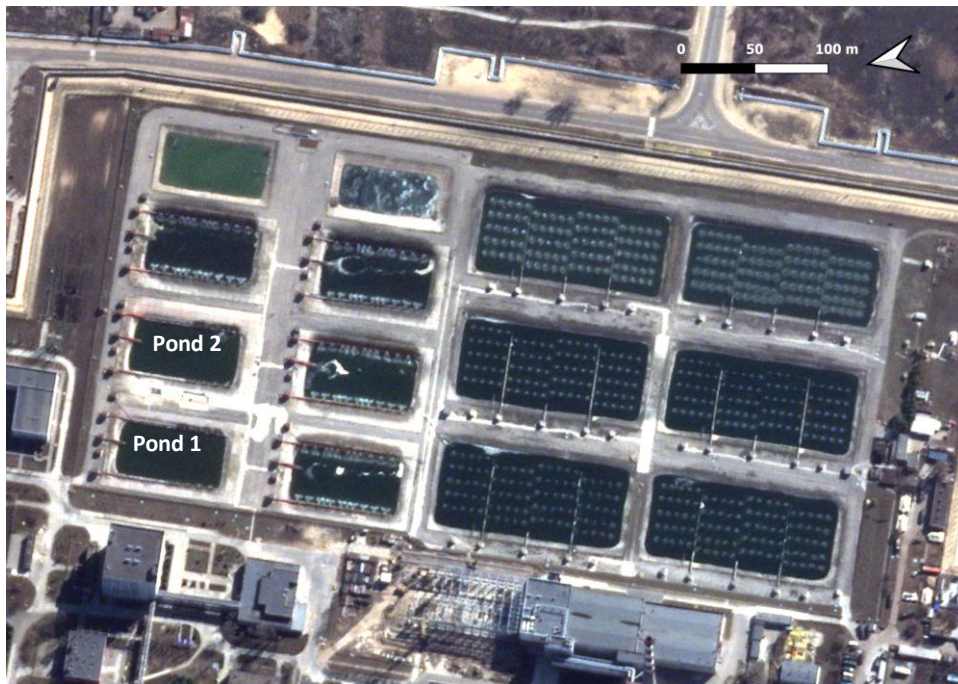
Within the plant, spray ponds 1 & 2 were inactive and the water pressure on spray ponds 3-6 appeared to be lower than was observed at other occasions (Fig. 10).

Fig. 10 – Inactive Spray Ponds

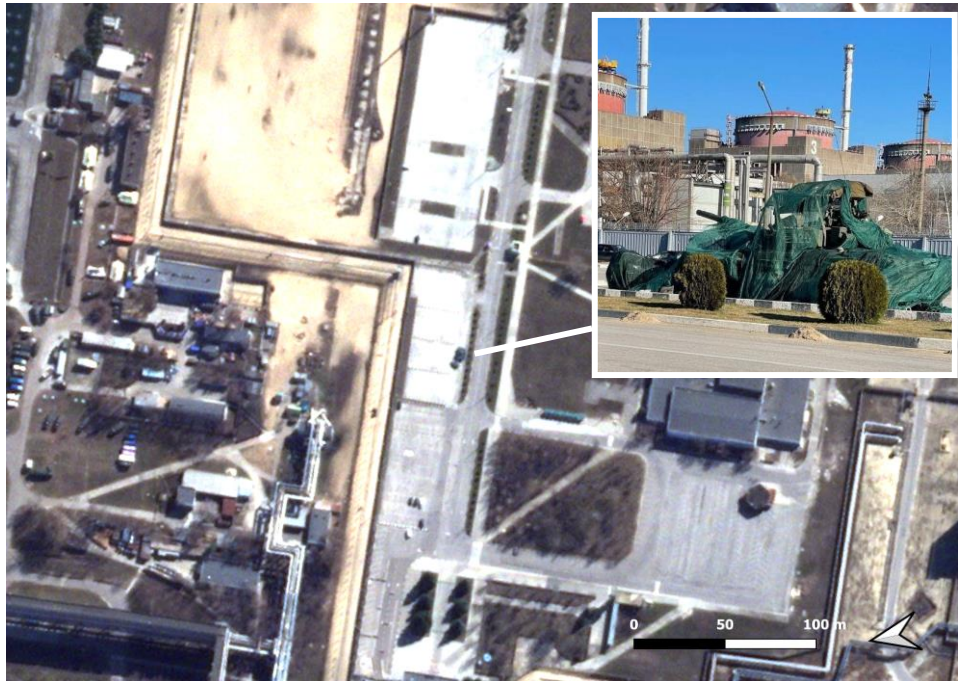
External to the plant, an object was observed in the car park adjacent to the main entrance and the training building (Fig. 11). An analysis of the precise position of this object and cross referred to a hand held image published by the Wall Street Journal from 5 July 2022 indicates the presence of a main battle tank (T-72 or T-80) under a rudimentary camouflage netting. Research of the Russian National Guard does not suggest that they were equipped with MBT at this time indicating likely assistance from the Russian ground forces during the initial firefight. Reporting suggests that following the mutiny of the Wagner group in June 2023, the Russian Duma has authorised the arming of the National Guard with heavy weapons including MBT. The position and posture of the MBT in the photo does not suggest that it has been positioned to guard the entrance to the plant. That the MBT has been camouflaged and its barrel pointing inwards may suggest that the MBT was damaged during the fighting of the initial assault and is unable to be moved to a more secure location and concealed from view of surveillance from unmanned aerial vehicle or satellite.

Fig. 11 – Concealed MBT in Car Park (Inset image BBC ‘Zapoizhzhia: Russian rockets damaged part of nuclear plant, Ukraine says’ dated 5 August 2022)

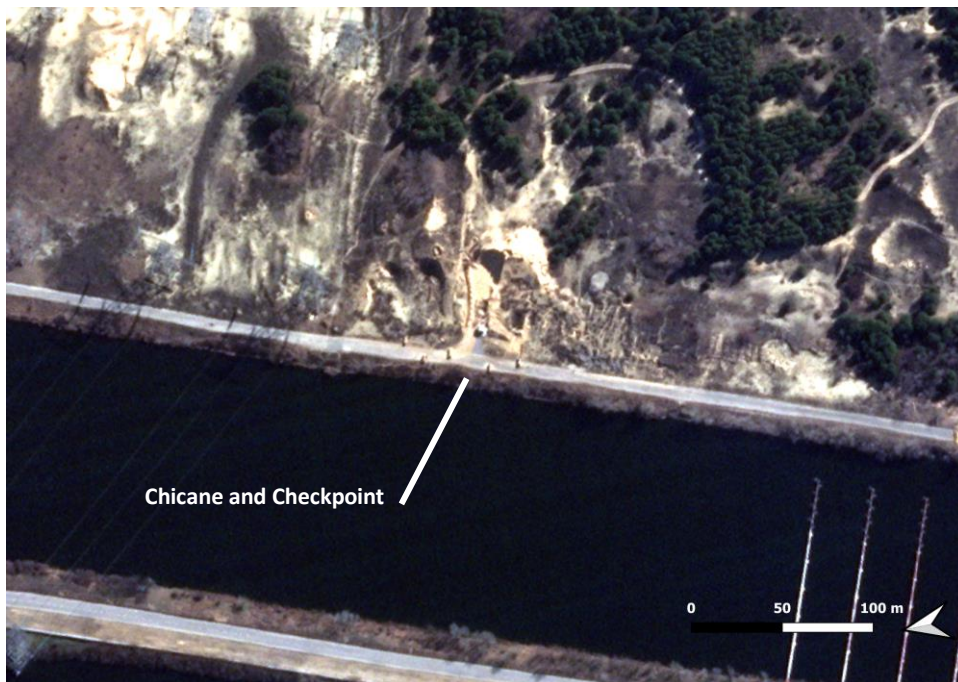
Elsewhere, external to the secure compound of the plant, a checkpoint and chicane have been constructed on one of the tracks approaching the plant from the south and to the immediate west of the transformer yard (Fig. 12) indicating the setting up of an outer cordon on the approaches to the plant.

Fig. 12 – Chicane and Checkpoint on Southwestern Approach

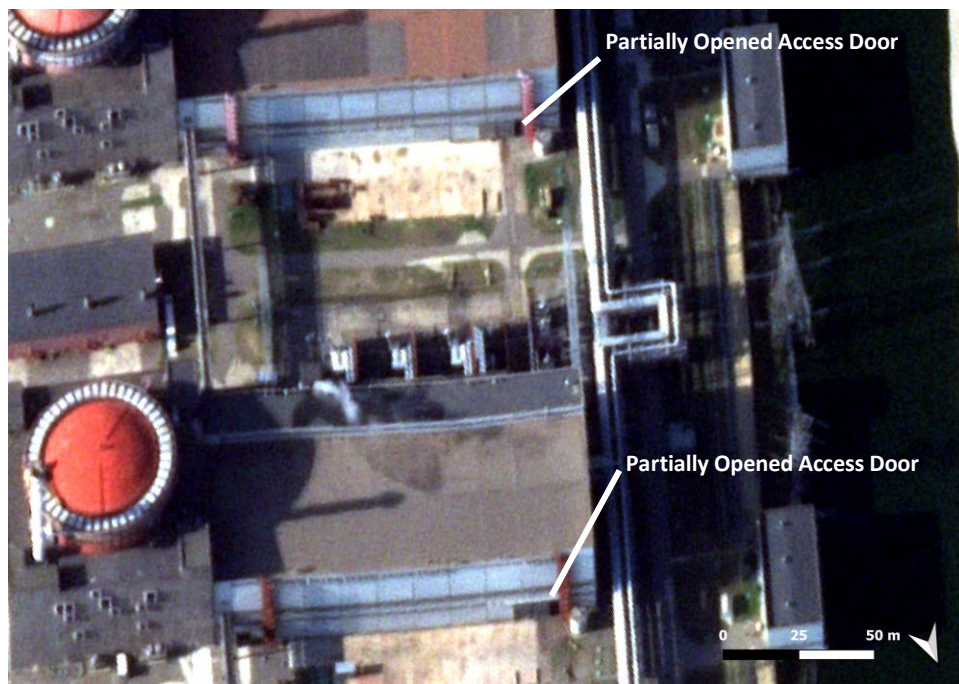
Fig. 13 – Open Access Doors, Turbine Halls 4 & 5

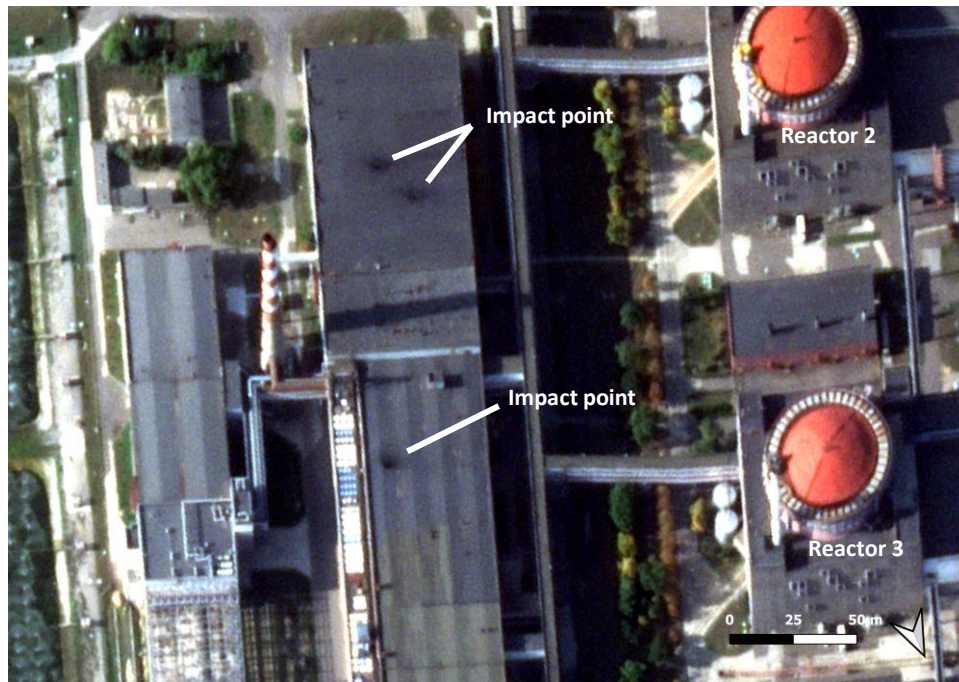
The imagery of 28 August also indicated damage to the roof of the large building to the east of reactors 2 and 3 (Fig. 14). Scarring suggesting impact from an unknown projectile was visible at three different positions on the roof. The exact date of the apparent impact is unknown. It cannot be determined from the imagery if the impacts had penetrated the roof structure. No other impact points were identified in the vicinity of the building or elsewhere in the plant.

Fig. 14 – Roof Damage and Impact points

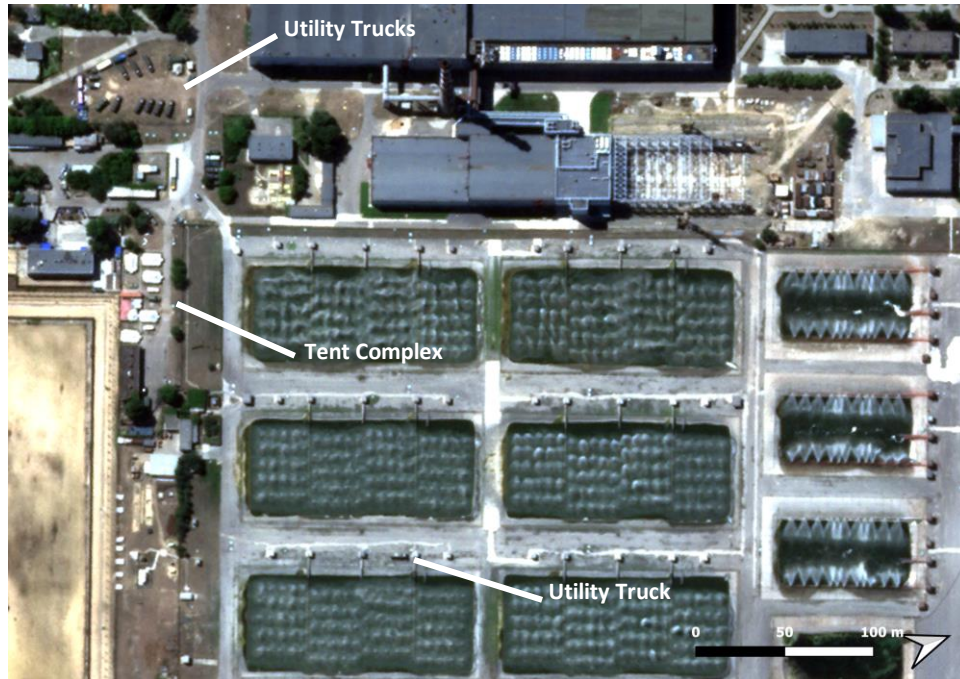
spray ponds 11 and 12 (Fig. 15). The vehicle appears to be a Kamaz utility truck, a slight change in tone on the top of the vehicle is likely to be a painted 'Z', a symbol used by Russian forces to mark their vehicles. All spray ponds were active.

Fig. 15 – Activity in Vicinity of Spray Ponds

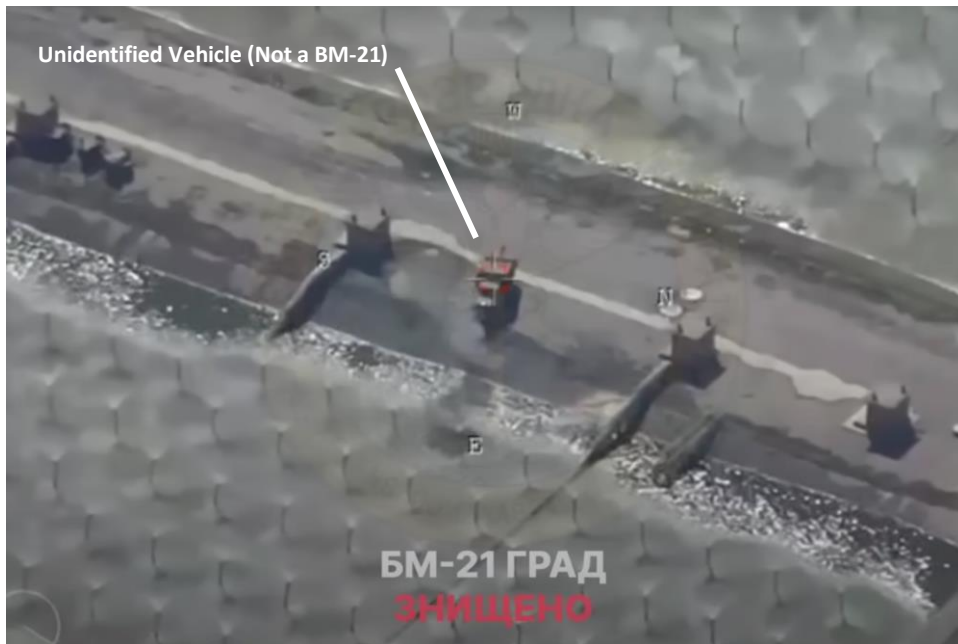
Ukrainian Defence Ministry video footage published on 25 July shows an attack against the Russian forces at the ZNPP and within the secure perimeter. The footage appears to show a small UAV (drone) attack against at least two targets. In both instances the explosive device is not substantial and is likely to be no larger than a grenade. The first attack claims to be against a BM-21 'Grad' Multiple Rocket Launcher (MRL). The video shows a small device detonating on a vehicle which is parked in between two of the spray ponds but the vehicle that is hit is not a BM-21 (Fig. 16). The device is not significant as there is little damage to the vehicle after the device detonates.

Fig. 16 – Vehicle Targeted for UAV Strike (YouTube - <https://www.youtube.com/watch?v=F9QmY0RKx8M&t=22s>)

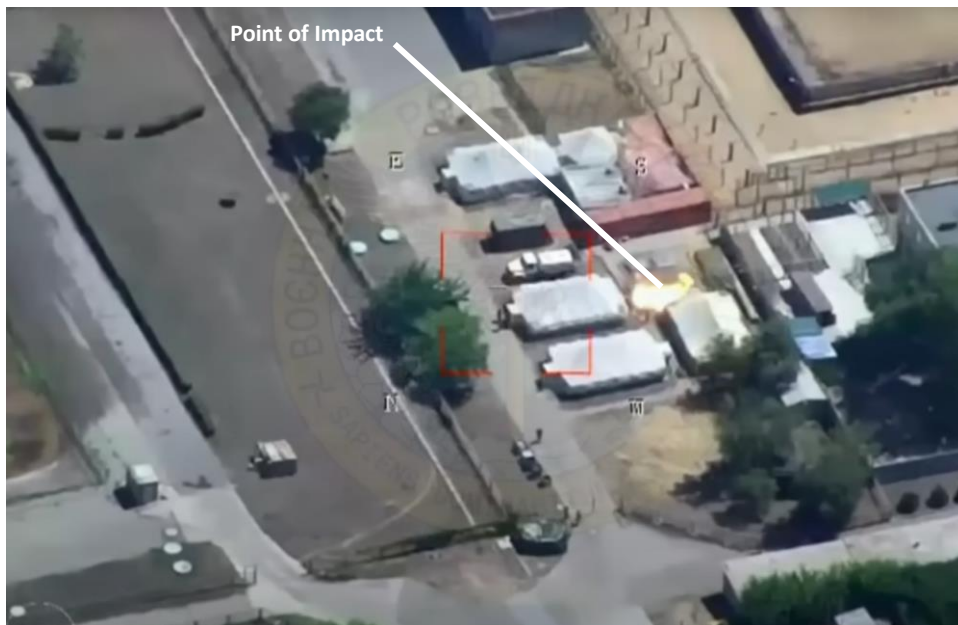
In the same footage, the UAV captures what appears to also be a UAV dropping a small device on the tented complex to the south of the spray ponds (Fig. 17). The device detonates in a small patch of ground to the rear of the tents. While the detonation appears to be quite significant, it does not appear to be a substantial munition. There is little initial damage and an individual passing at the point of detonation does not appear to be significantly injured.

Fig. 17 – UAV Strike on Tent Complex (YouTube - <https://www.youtube.com/watch?v=F9QmY0RKx8M&t=22s>)

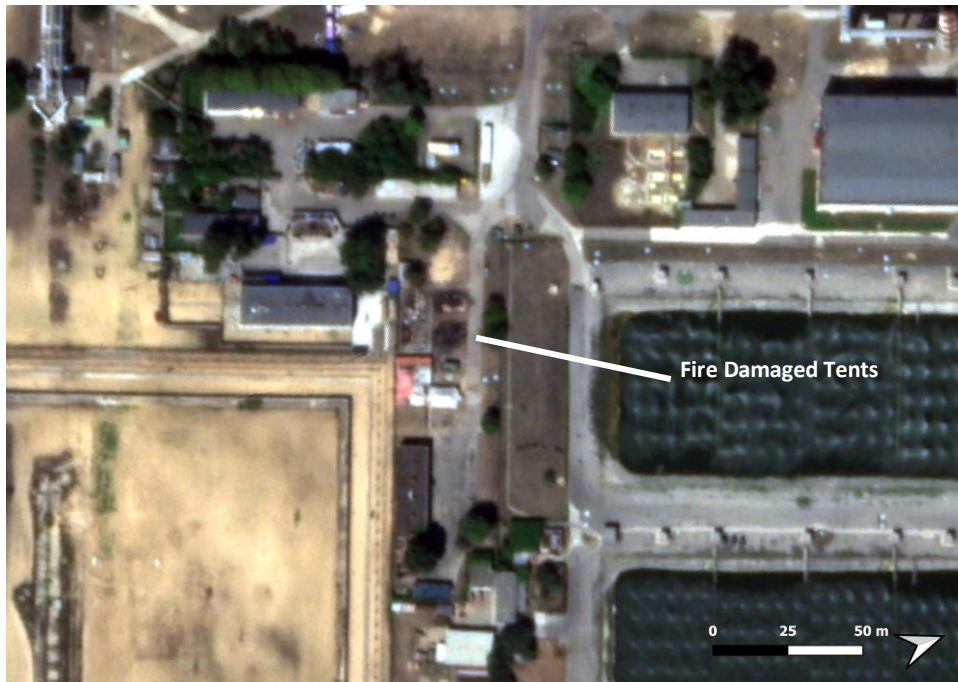
Later in the footage, fire fighters are observed fighting a fire amongst the tents. Imagery from 24 July 22 identifies that the tent complex has mostly burnt down (Fig. 18). The utility trucks previously observed parked on the open ground are no longer present.

Fig. 18 – Tents Damaged and Destroyed by Fire

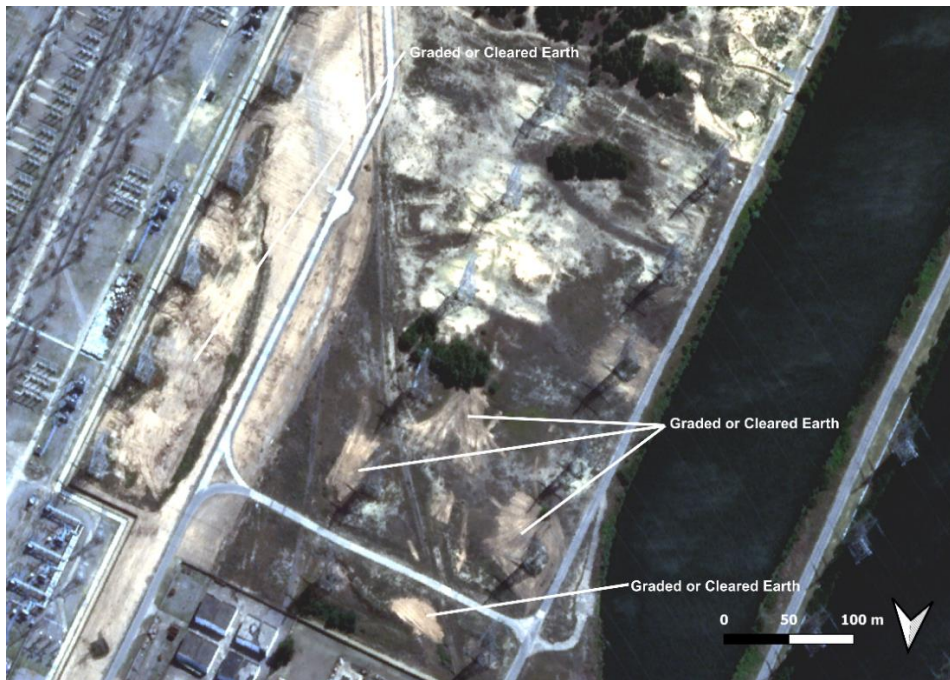
The earth around the pylons to the immediate west of the transformer yard has been graded, most likely by heavy plant equipment (Fig. 19). The reason behind the works is unclear. It is highly unlikely that the area has been prepared for artillery or rocket firing positions as the area has a large concentration of overhead power lines. Some of the graded areas have removed vegetation but not all of them, also some vegetation remains so it is also unlikely that the works were carried out to clear the area of vegetation. It is possible but unlikely that the area may have been mined but cannot be confirmed from imagery. Other than creating a perimeter security in depth, there is no logical, tactical or operational reason for mining this area of the plant.

Fig. 19 – Area of Graded Earth by Transformer Yard

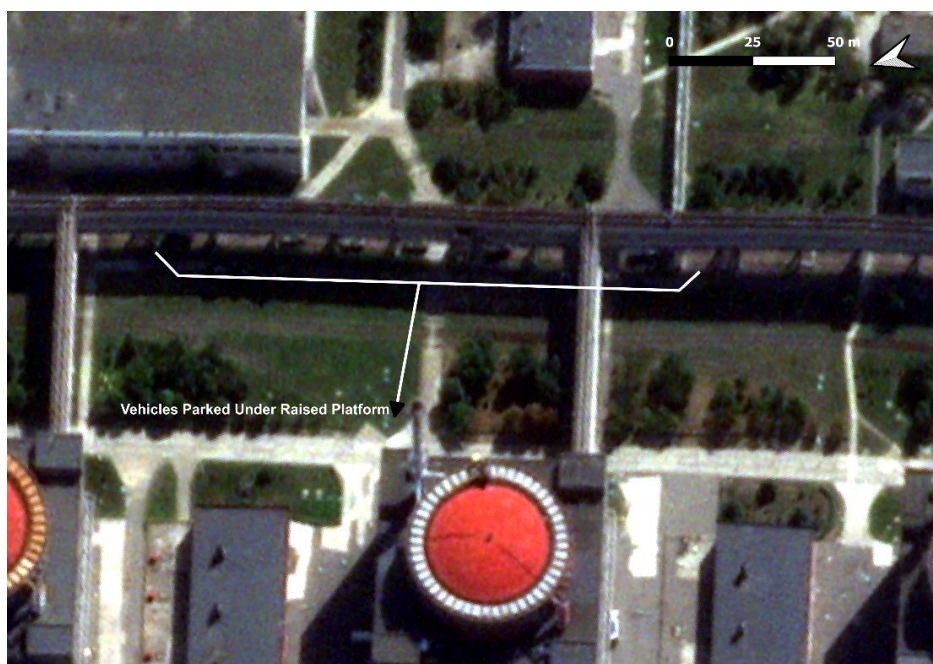
Imagery of 21 August 2022 was collected at a low angle off-nadir and identifies vehicles parked under a raised structure between the supporting struts (Fig. 20). The vehicles remained in this position until at least 21 September when they were also observed in the same position. The vehicles are both utility trucks and likely heavy armoured vehicles such as the BTR-80 APC which has been seen within the plant on previous imagery. The significance of the parking of the vehicles under the raised structure is both concealment and protection from overhead attack as previously sustained earlier in the occupation.

Fig. 20 – Concealed Utility and Armoured Vehicles

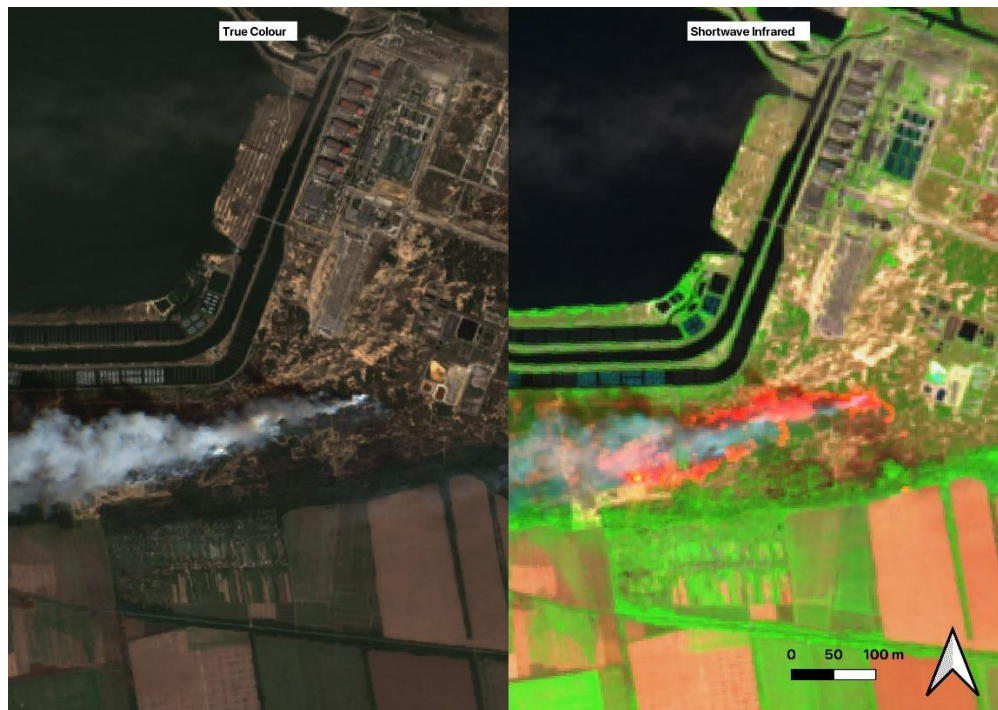
Sentinel 2 Imagery of the plant indicated a large fire was burning in the area of undergrowth to the immediate south of the plant and adjacent to the transformer yard. The fire was only identified by a column of smoke on true colour imagery but the actual extent of the fire was clearer when viewed utilising the shortwave infrared band of the Sentinel 2 platform (Fig . 21).

Fig. 21 – Fires Burning to South of ZNPP (Copernicus Sentinel data 2023)

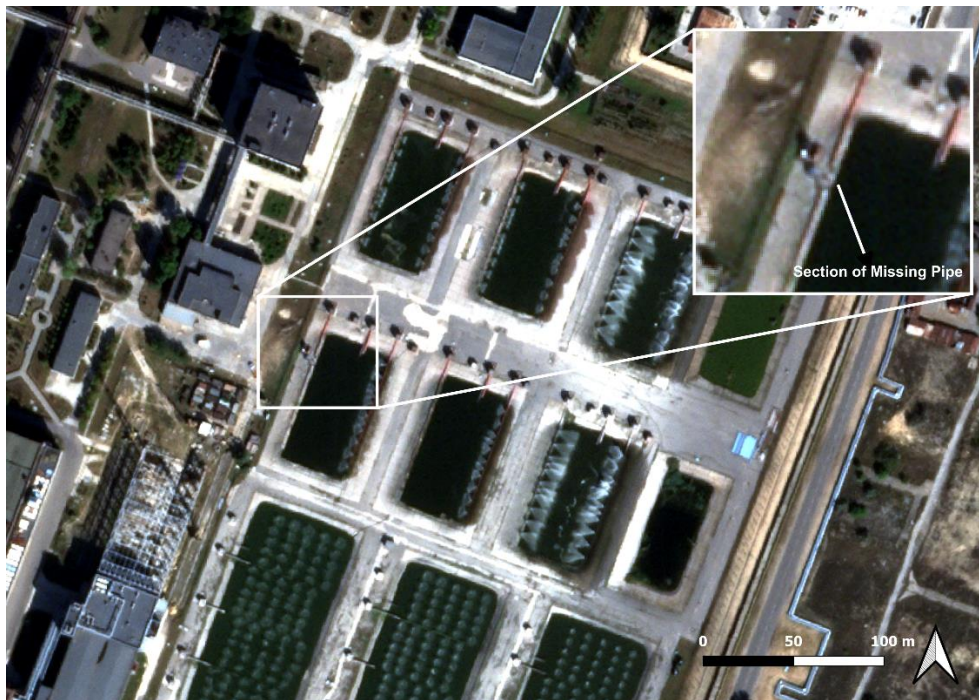
Fig. 22 – Concealed Utility and Armoured Vehicles

Open source reporting³ reports that shelling of the plant occurred during the early hours of the morning of 21 September 2022. The shelling reportedly damaged cables providing power to one of the reactors and emergency power generators automatically powered up to provide power to the reactor for approximately 40 mins until the power supply was reconnected. The same article details a previous shelling in the area of the spray ponds on 20 September which resulted in one of the ponds becoming non-operational. Imagery of 21 September confirms that ponds 4 and 5 had only half of their jets operating. Imagery of 23 September 2022 appears to show damage and possible repairs being conducted to pond 4. A break in the shadow confirms that a section of the pipe has been removed (Fig. 22). Spray ponds 4 and 5 remained only half functional until 15 October 2022 at the latest.

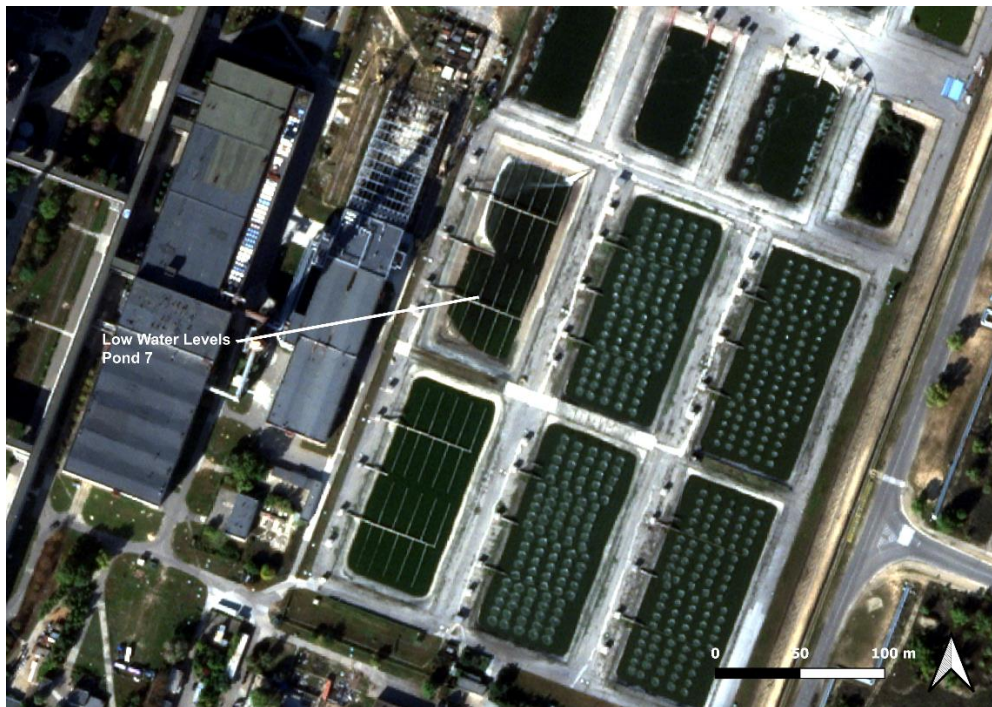
Imagery collected on 4 October identifies that only half of the jets remain operational on spray ponds 4 and 5 although the repairs to the pipe on pond 4 appear to have been completed. Two of the larger ponds, 7 and 10 are not operational at all. Ponds 7 and 10 remained non-operational on 8 October and the water levels on pond 7 were significantly lower than usual (Fig. 23). Pond 7 was filled to usual levels by 9 October but both ponds 7 and 10 were still not working. All spray ponds were back to normal by 15 October although the pressure of the jets was lower than usual in ponds 7 and 10.

Fig. 23 – Spray Ponds, 8 October 2022

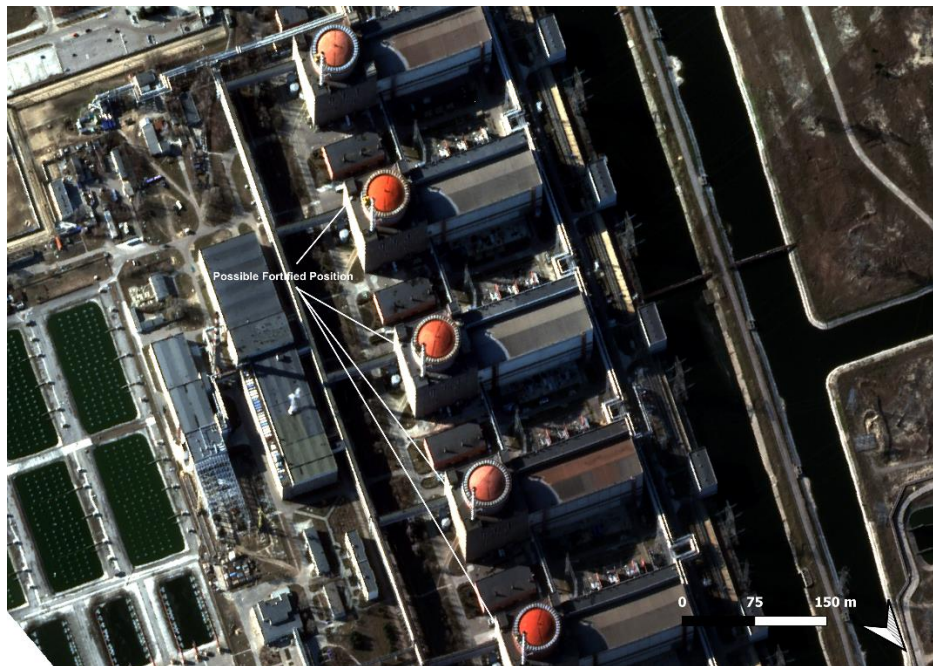
The sangars were still present on imagery from September 2023.

Fig. 24 – Construction of Positions on Reactor Hall Roofs.

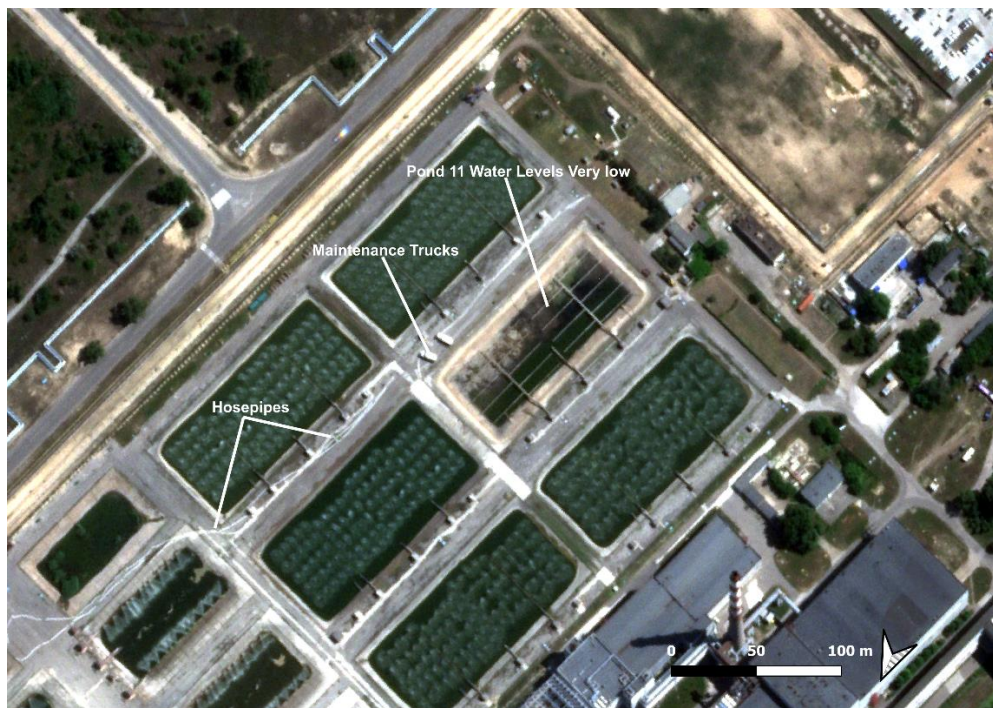
As at 4 June 2023, spray pond 11 was non-operational. Two white trucks, possibly maintenance related, were parked next to the pond. By 6 June, pond 11 was almost dry. The two white trucks remained next to the pond (Fig. 25). A network of hosepipes had been laid out on the ground leading to other ponds. On imagery from 8 June, the pond was again operational and the water level was returning to normal.

Fig. 25 – Spray Ponds, 6 June 2023

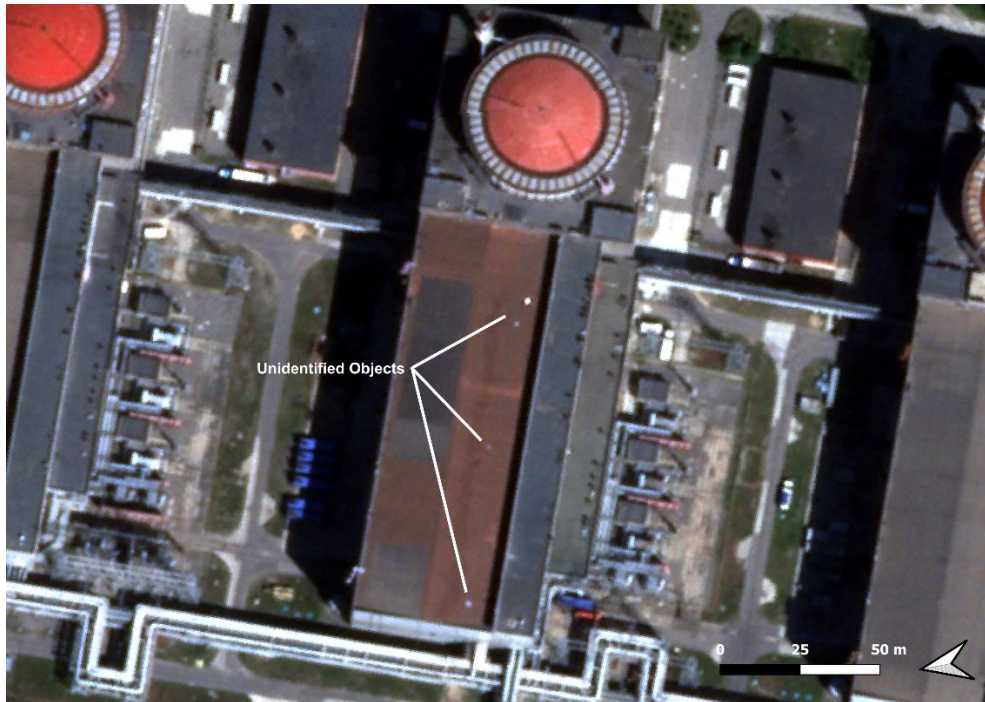
The roof of the turbine hall associated to reactor 4 displayed a number of unknown white objects (Fig. 26). These objects were first identified on imagery dated 4 June 23. It cannot be determined from imagery what the white objects are. The resolution of the imagery also prevents accurate mensuration, but it is estimated that they are approximately 2m by 2m, this is only an estimation however.

Fig. 26 – Unidentified Objects on Roof of Turbine Hall No. 4

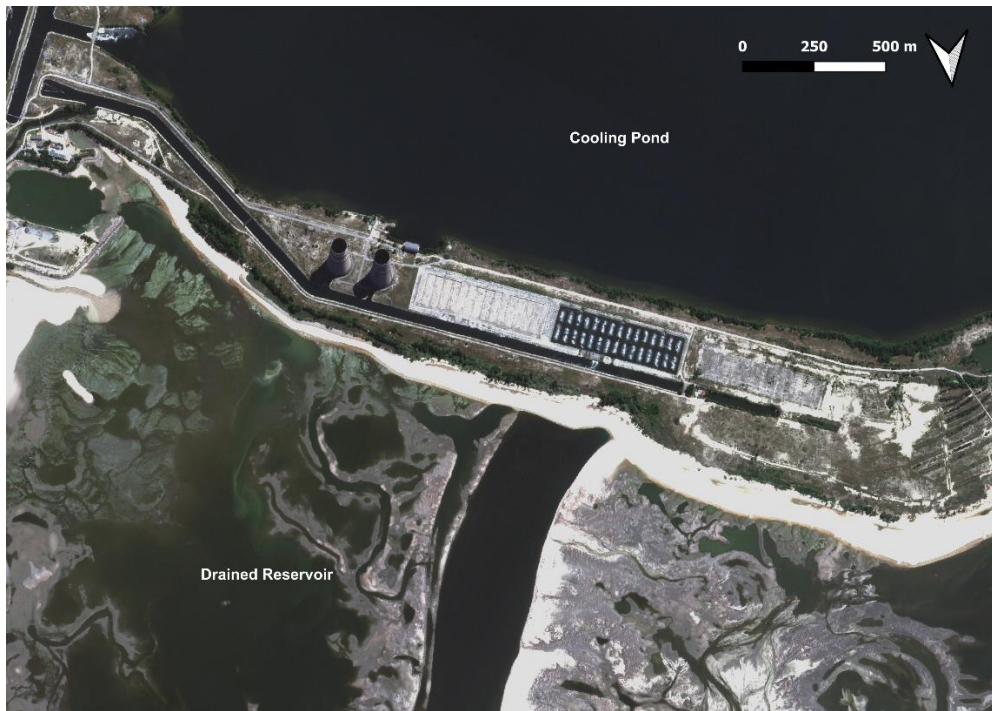
Following the destruction of the Kakhovka dam on 6 June 2023, water levels began to drop in the reservoir which formed the northern boundary of the nuclear power plant. Imagery of 16 June identified the catastrophic drop of the water level around the large cooling pond of the plant (Fig. 27). The water levels had dropped to such a level that only the channel of the river was evident with the majority of the bed of the reservoir now dry.

Fig. 27 – Drained Reservoir adjacent to ZNPP Cooling Pond

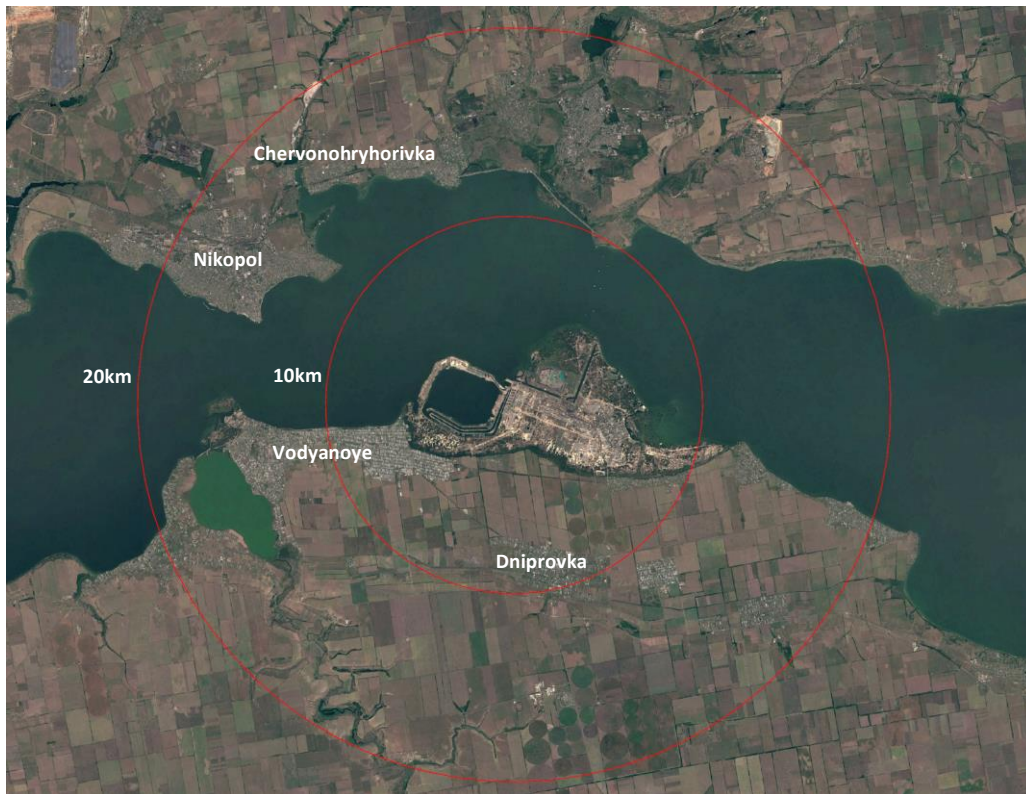
Fig. 28 – Environs of ZNPP out to 20 Kilometres

A wider study of the ground further out from the plants was conducted to identify any military activity which could impact the safety of the plant or identify elements that may be using the plant as a shield to prevent themselves from being targeted by indirect fire. A plan of the wider area covered in this study is at Fig.28 below.
