A Nuclear Power Plant as Launch Pad

Analysis of the occupation of Zaporizhzhia NPP
by Russian armed forces and Rosatom and
the role of the IAEA

**Analysis of the Russian Seizure
and Ongoing Occupation of the
Zaporizhzhia Nuclear Power Plant (ZNPP)**

September 2023

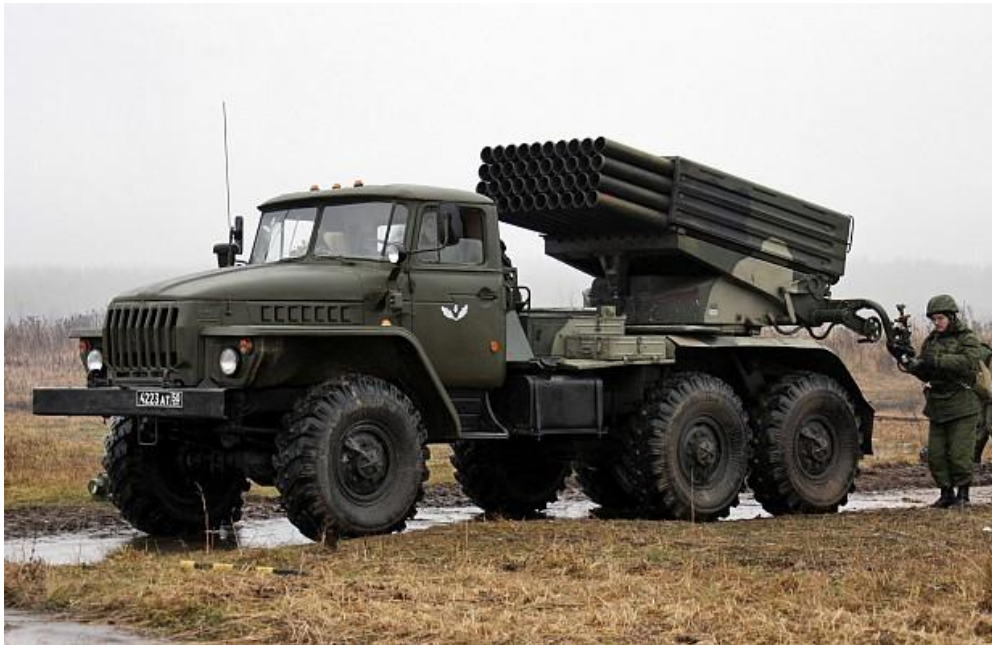
Fig. 29 – BM-21 ‘Grad’ Multiple Rocket Launcher (Unattributed)

Open source information⁴ suggests that the Russian forces have positioned ‘Grad’ batteries in the nearby town of Vodyanoye, approximate 6km west of the plant. Grad is the Russian nomenclature for the BM-21 MRL (Fig. 29) which is a common piece of military equipment. It is a truck mounted rocket launcher that fires salvos of up to 40 x 122mm rockets from each launcher, with 4 to 6 launchers per battery. Throughout the course of the study, no BM-21 were identified within the plant or the wider area. That does not suggest that the launchers are not present however. It would be common practice for the batteries to be concealed or camouflaged when not firing. Batteries will typically deploy to pre-surveyed sites to fire their salvos and will then immediately return to their concealed positions in order to prevent targeting by counter-battery fire. Firing positions need to be surveyed in order to calculate the accurate fall of rockets and shells. This takes into account ground elevation, atmospheric conditions etc. the weapon systems can then move into position from their lay-up positions and fire their salvos before quickly vacating their positions to alternate firing points or return to their lay-up positions. In taking up their firing positions, there will be a certain amount of manoeuvring of the systems in order to achieve the required firing position, such as orientation and levelling of the platform, this will leave disturbance of the ground such as vehicle tracks which appear to be nonsensical. In addition, self propelled artillery systems are designed to be used across rough terrain so vehicle tracks will also be observed crossing fields and over non-mettled surfaces. The study did identify ground marking which suggests that these launchers are being used in close proximity to the plant.

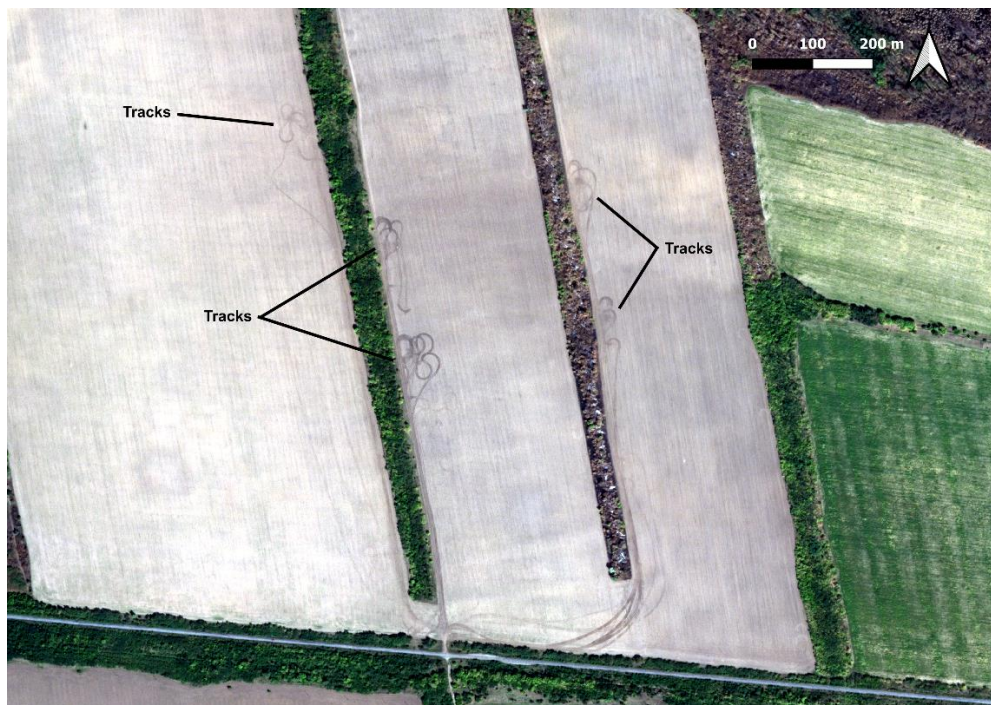
Track marks in fields which do not suggest logical agricultural practice were identified in numerous places at different times over the reporting period (Fig.30). These tracks are likely to be evidence of launchers moving to their firing positions and then departing afterwards. Ground scarring was also identified which indicates firing of rockets had taken place.

Fig. 30 – Tracks Indicating In-Direct Fire Firing Points

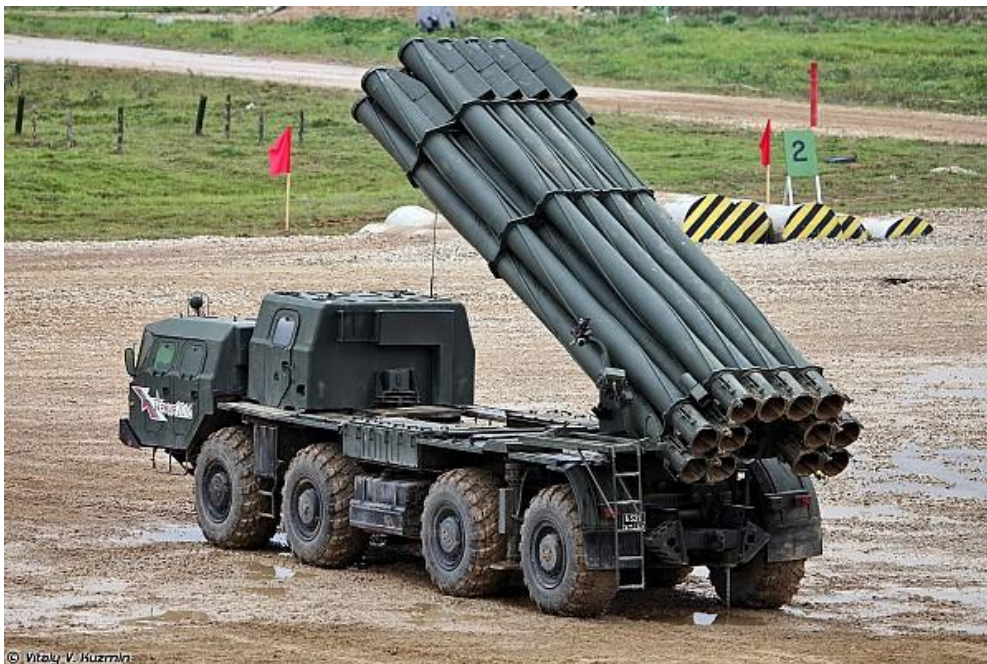
Fig. 31 – BM-30 'Smerch' Multiple Rocket Launcher (WeaponSystems.net)

Measurement of some of the tracks indicated a vehicle which was approximately 3m wide; the BM-21 is only 2.4m wide. The BM-30 ‘Smerch’ (Fig. 31) is a larger MRL in use by the Russian ground forces which can fire up 12 x 300mm rockets per salvo. The launcher for this system is

3.05m wide. It is not unusual for the term 'Grad' to be assigned to any truck mounted rocket launcher; it is possible that either or both systems have been deployed in the wider area of the plant. Eitherway, the launchers will be subordinate to the Russian ground forces and not the National Guard so will not be under the operational command of the forces deployed to the plant. Western Forces would be expected to have some form of liaison between different organisations operating in the same area in order to deconflict and prevent instances of fratricide, this could be in the form of an exchange of officers or through a dedicated communication net. It is likely that there would be some form of liaison between the National Guard elements and Armed Forces units to ensure that both elements' operations do not interfere with each other and prevent any accidental clashes, especially in close proximity to the front line.

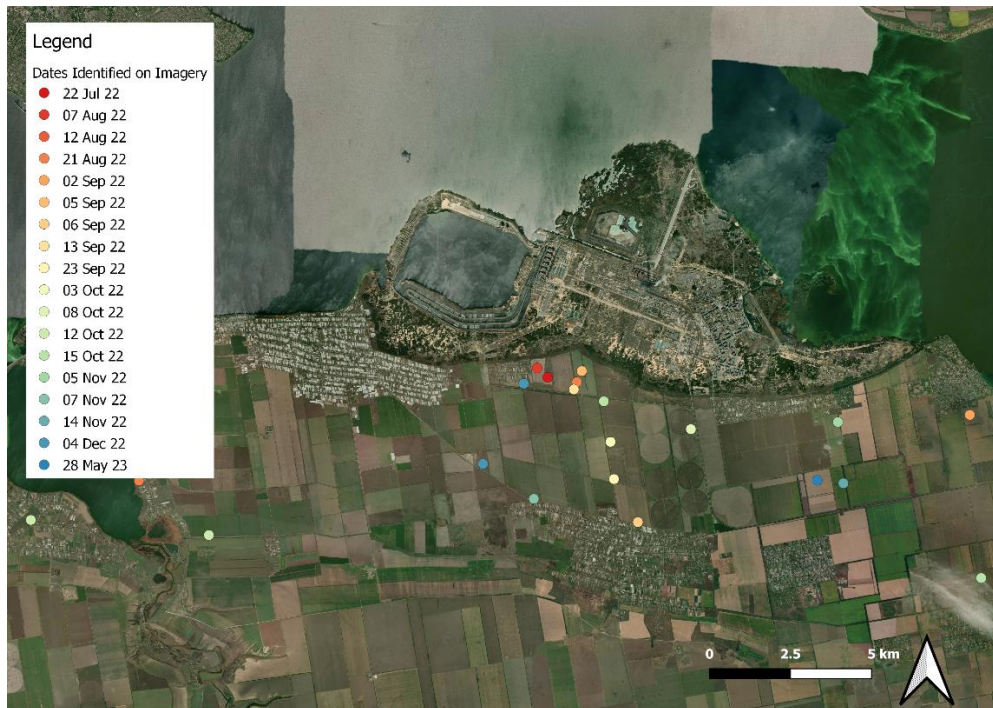
Fig. 32 – Map of Potential Firing Points

A number of potential firing points were identified in the wider area of the plant over the reporting period. The map below (Fig. 32) and subsequent paragraphs detail the location of the potential firing points and the date they were identified on imagery. There was a reduction in ground signs of possible firing positions after December 2022 which would indicate a significant drop in artillery activity in the wider area around the plant. An analysis of reporting conducted by the Institute for the Study of War indicates that the Russians are having to deviate from their doctrinal norms and evolving and adapting to the battlefield. A degradation of artillery assets, barrel wear, critical problems with supplying frontline units and very low stocks of ammunition have curtailed their use of this form of warfare. Ukrainian counter battery fire has also improved significantly since the start of the war due to a number of factors including the supply of superior western systems, training and experience. This has also forced the Russians to adapt their employment of battlefield artillery and prioritize accuracy over volume of fire; their default use of this type of weapon. The Russians are also now fighting a defensive battle, particularly in the south along the Zaporizhzhia and Donetsk administrative borders. This, along with the degradation of their artillery assets and paucity of ammunition, has likely forced them to redeploy their assets to those areas of the battlefield where they are required the most. The Russians have likely assessed that the area around

the nuclear power plant is not under imminent threat of the Ukrainian counter-offensive and as such there is no tactical or operational reason to maintain artillery units in this area.

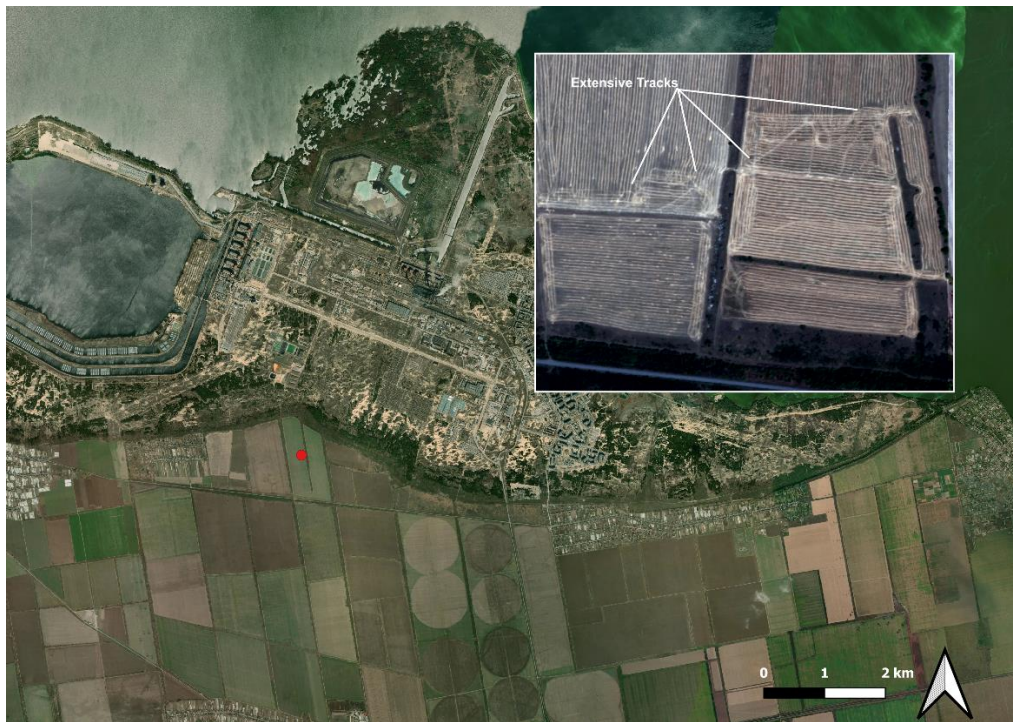
Distance from ZNPP – 3.2km south of plant.

Fig. 33 – Potential Firing Point – 22 July 2022

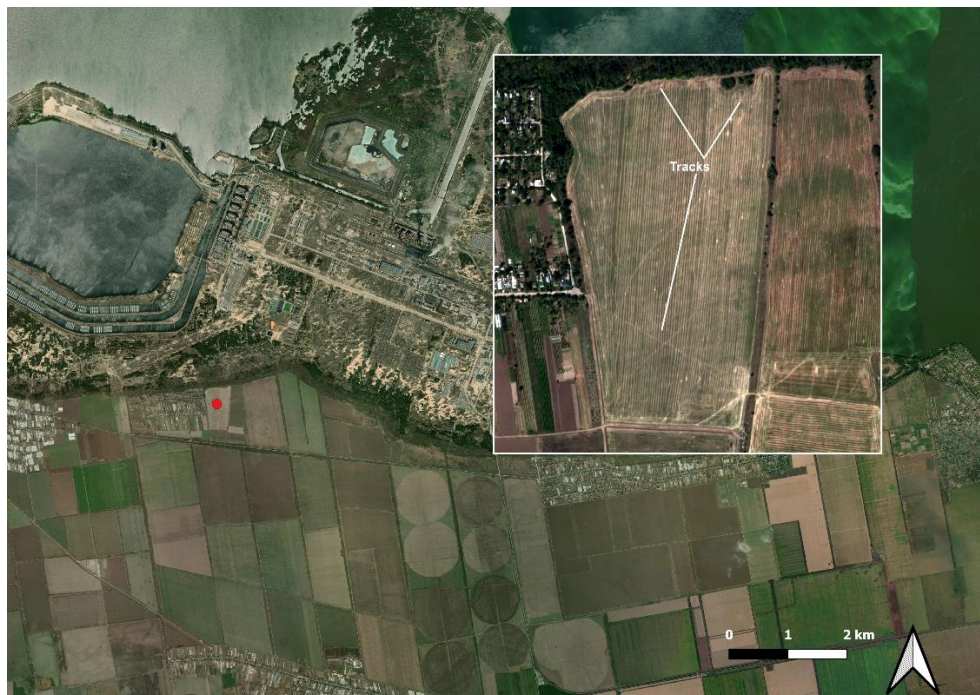
Multiple tracks across and around the perimeter of a large field which appeared between 31 July and 7 August (Fig.34). While not indicative of artillery activity, the tracks do not suggest normal agricultural activity. Coordinates – 47.48254, 34.58184. Distance from ZNPP – 2.9km south of plant.

Fig. 34 – Potential Firing Point – 7 August 2022

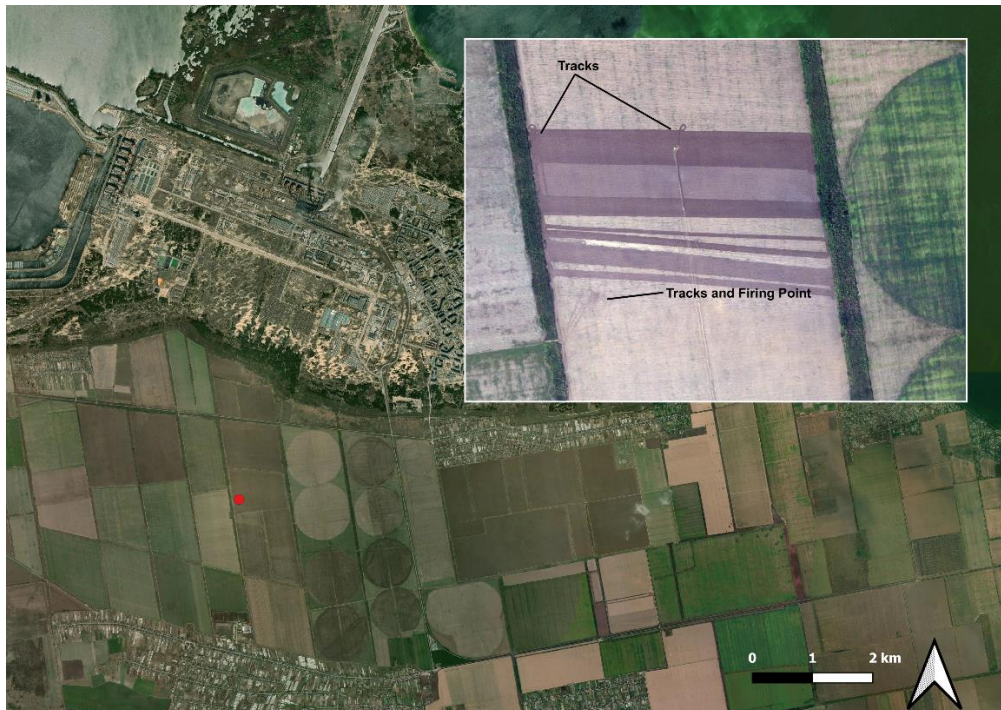
Tracks along the edge of the perimeter of a field are indicative of a launcher or launcher deploying to firing point, manoeuvring into position and firing a salvo (Fig.35). There are at least three separate positions that have appeared between 7 and 12 August 2022. The field appears to have been ploughed or agriculturally prepared after the tracks were made. Coordinates – 47.46458, 34.61114. Distance from ZNPP – 4.8km south-southeast of plant.

Fig. 35 – Potential Firing Point – 12 August 2022

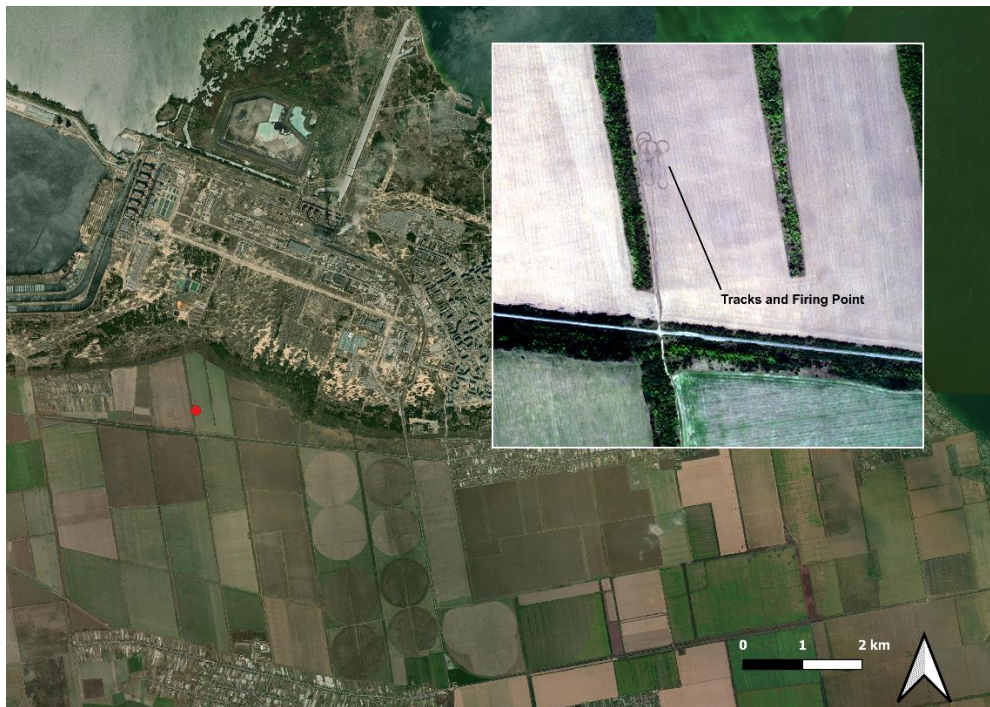
Tracks evident along the edge of a field suggest the deployment of at least one vehicle (Fig.36). The tracks indicate movement into the field along the hedgerow from the road to the south and then breaking into the field. Where the tracks move into the field, it indicates an amount of manoeuvring, most likely into a firing position. Coordinates – 47.47864, 34.59788. Distance from ZNPP – 3.2km south-southeast of the plant.

Fig. 36 – Potential Firing Point – 21 August 2022

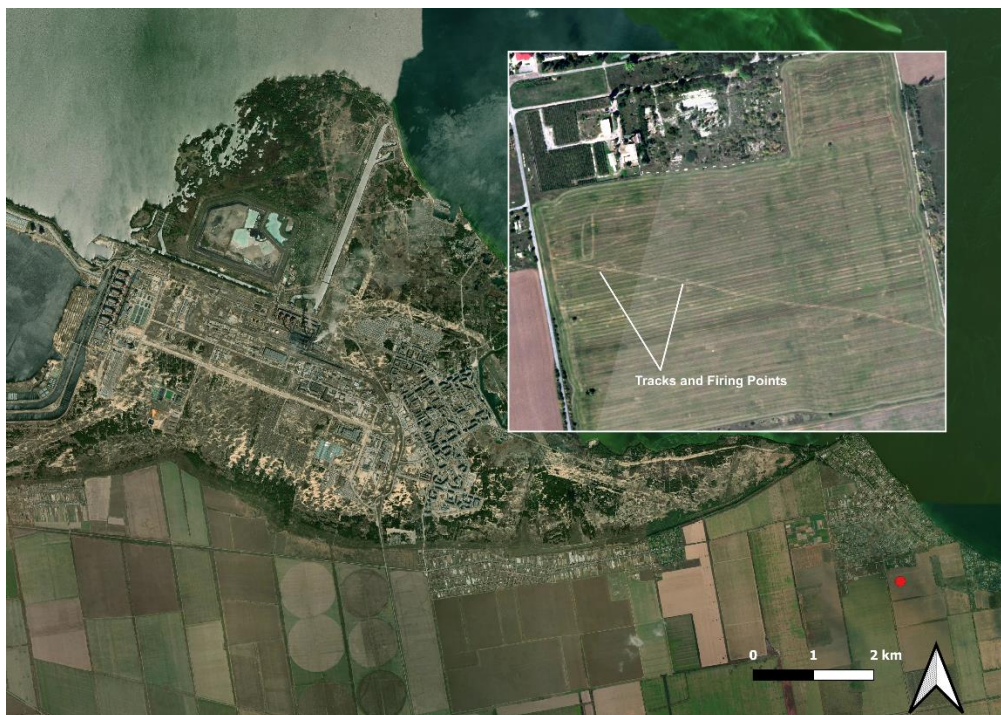
Track in a large field may indicate activity or possible firing point to the east of ZNPP (Fig.37).
 The tracks do not suggest normal agricultural activity.
 Coordinates – 47.47002, 34.75996.
 Distance from ZNPP – 13.8km east-southeast of the plant.

Fig. 37 – Potential Firing Point – 2 September 2022

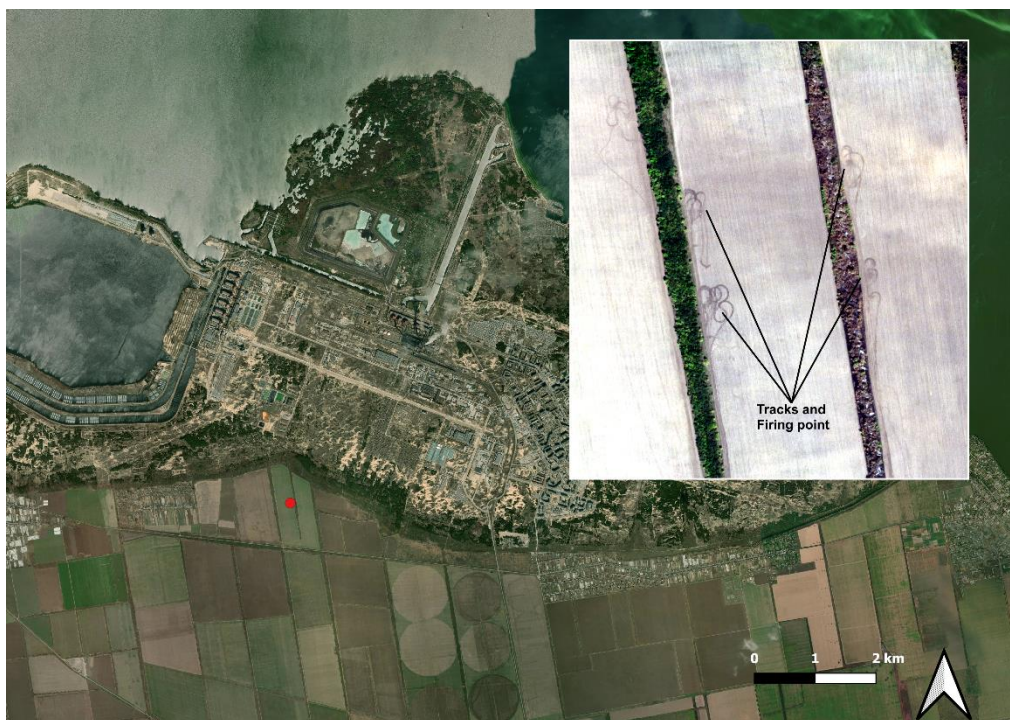
Fig. 38 – Potential Firing Point – 3-7 September 2022

Fresh tracks were identified on an image from 7 September 2022 (Fig.38) which would have been made between 2-7 September 2022. There are a number of tracks projecting into the field after traversing along hedgerows to access the field, indicating tactical transit of the vehicles. The tracks are indicative of the vehicles manoeuvring into position, most likely to fire a salvo. The number of separate tracks indicates a battery level fire mission. It is possible that this is the location of the salvo that was captured on CCTV footage discussed in paragraph 8.2.19 of this report.

Coordinates – 47.48008, 34.59765.

Distance from ZNPP – 3.1km south-southeast of the plant.

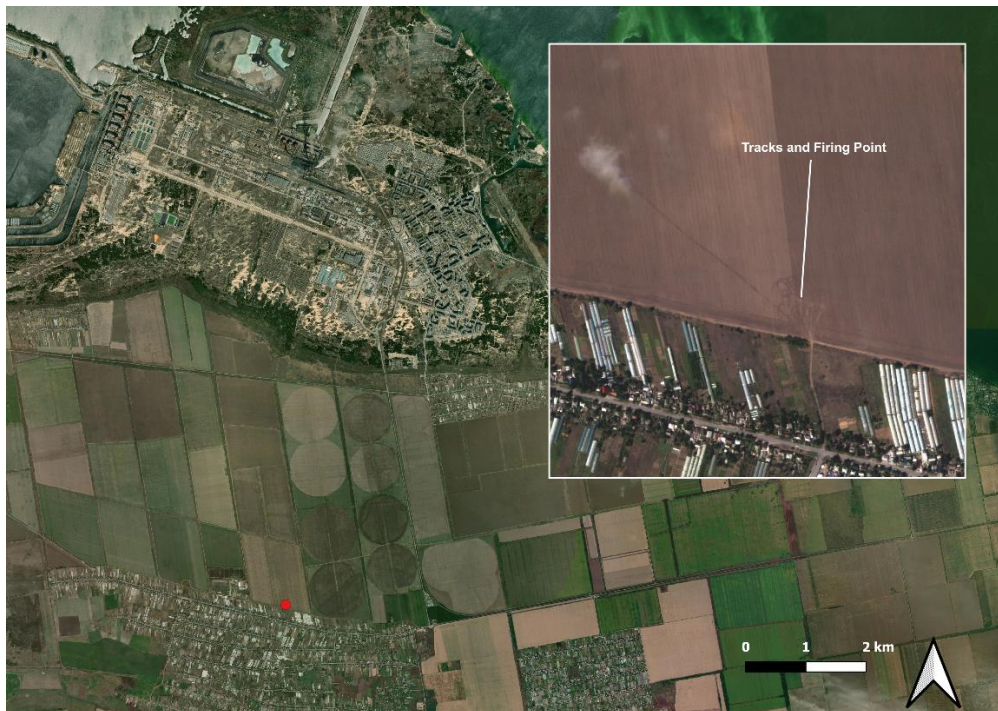
Fig. 39 – Potential Firing Point – 6 September 2022

Tracks at the entrance to the field off the northern track of the settlement of Dniprovka could indicate normal farm traffic (Fig.39). However, the tracks also reveal manoeuvring of a vehicle which could indicate adopting a firing position. A single vehicle track also moves from the entrance, northwest wards into the field.

Coordinates – 47.43973, 34.62283.

Distance from ZNPP – 7.9km south-southeast of the plant.

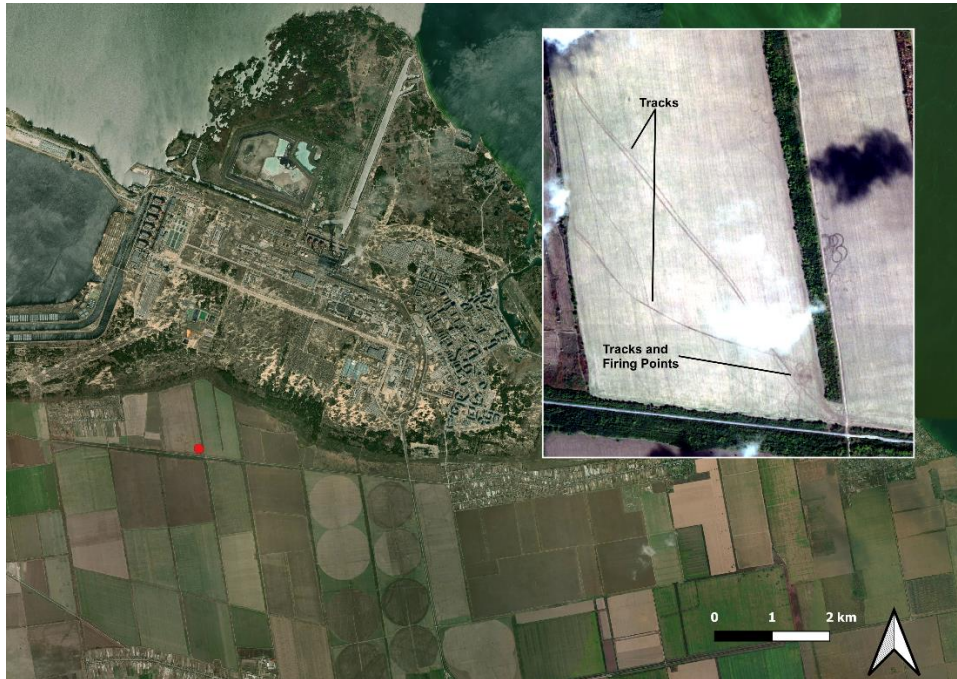
Fresh tracks were observed at the entrance to the field and evidence of vehicle manoeuvring (Fig.40). There also appears to be possible ground scarring indicating launching of rockets although the absence of vegetation cannot ~~confirm~~ confirm this as there is no burn scar. The tracks also lead off in a north westerly direction indicating multiple vehicles.

Fig. 40 – Potential Firing Point – 13 September 2022

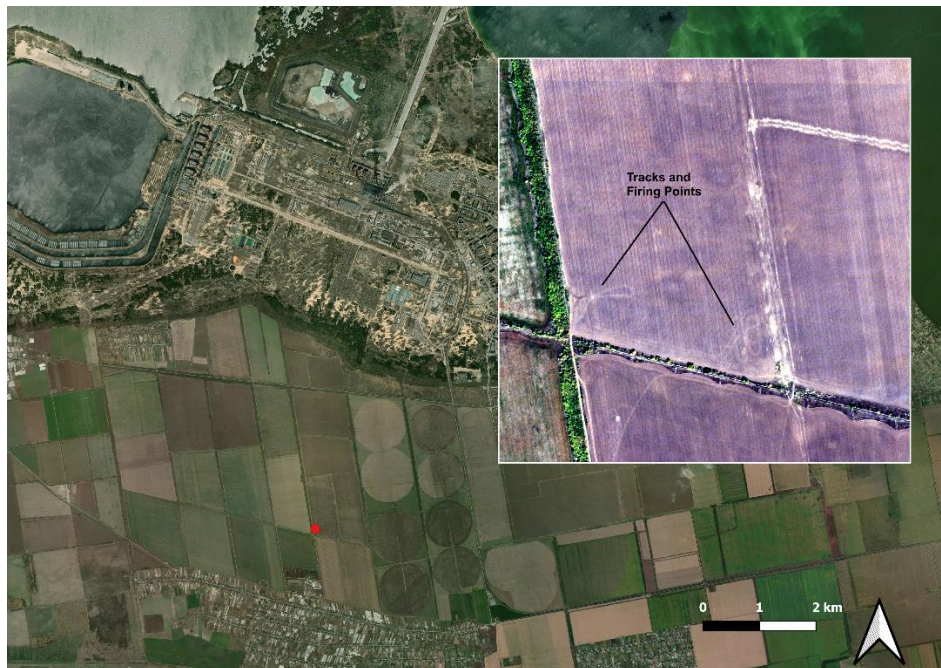
Faint tracks were observed in the southern part of a field to the south of the plant (Fig.41). The tracks were made between 7-18 September 2022 but were most clearly observed on imagery from 23 September 2022. The tracks indicate vehicle moving into the field along hedgerows before projecting into and manoeuvring in the field. Coordinates – 47.45198, 34.67459. Distance from ZNPP – 6.5km south-southeast of the plant.

Fig. 41 – Potential Firing Point – 23 September 2022

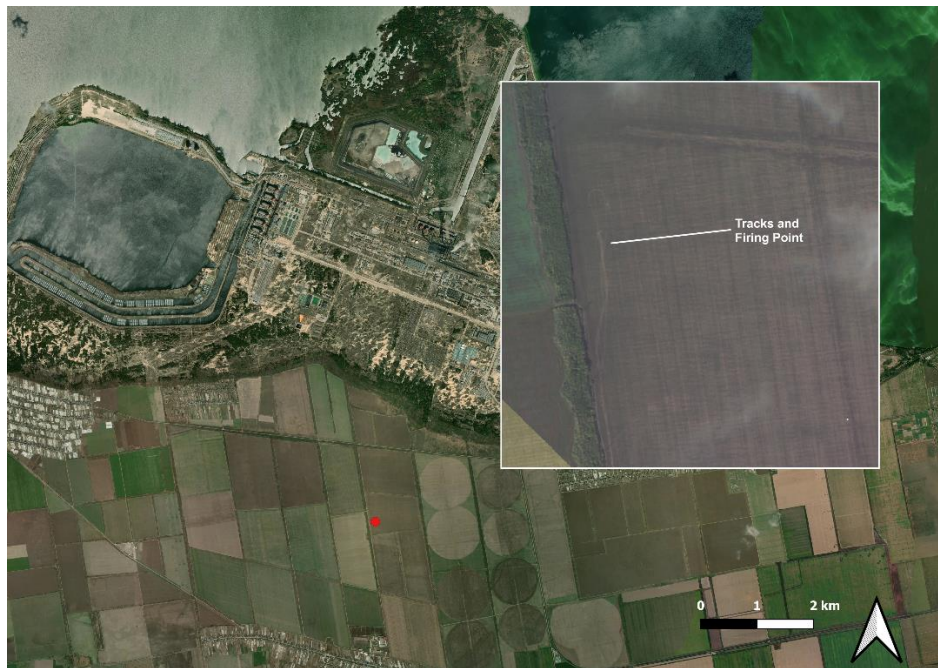
Fresh tracks were observed in a field indicating a vehicle entering the field along the hedgerow before moving further out into the field (Fig.42). There is minimal vehicle manoeuvring tracks but it appears the vehicle drove straight into the firing position, launched its fire mission before driving away in a narrow loop and returning along the path it used to enter the field. The activity is likely to have occurred between 23 September to 3 October 2022.

Fig. 42 – Potential Firing Point – 3 October 2022

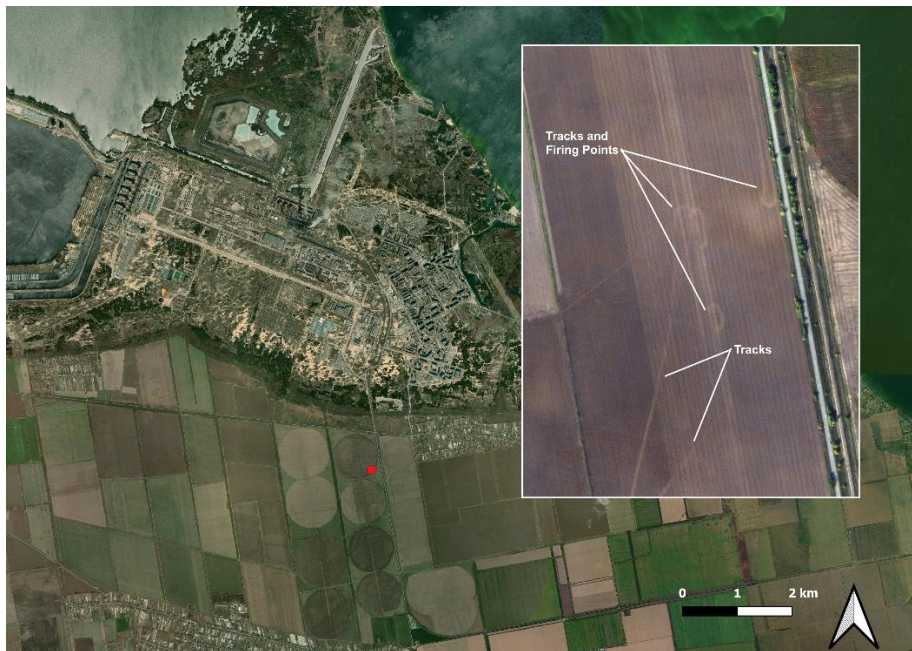
Vehicle tracks were observed in a freshly ploughed or prepared field (Fig.43). The tracks move to the centre of the field after transiting along hedgerows. There is also evidence of manoeuvring in the centre of the field.

Fig. 43 – Potential Firing Point – 8 October 2022

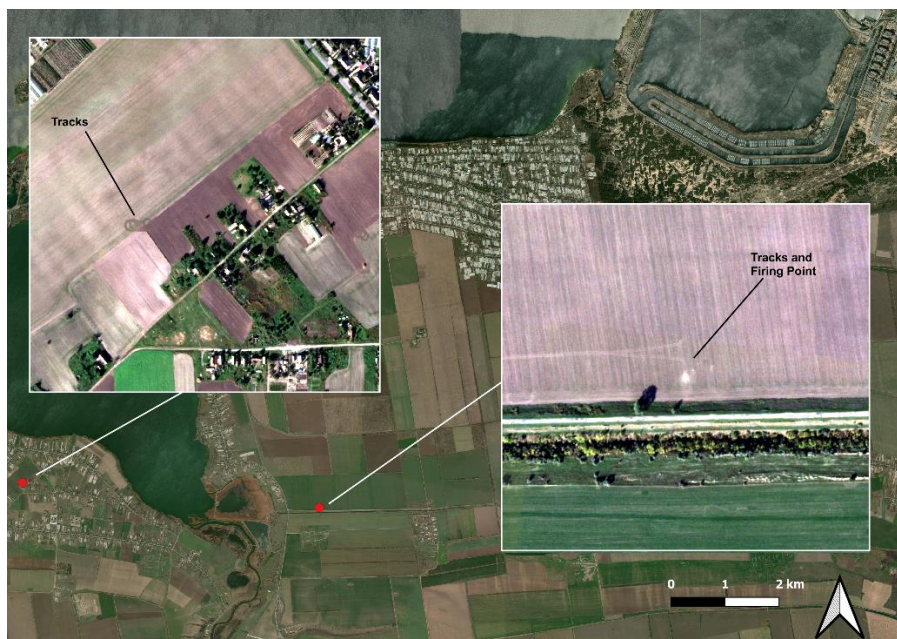
Two likely firing positions were identified to the southwest of the plant in the vicinity of the small settlement there (Fig.44). It appears that each location was used by one vehicle but this cannot be confirmed. In each position, vehicle tracks are observed leading to the likely firing point where the tracks indicate vehicle manoeuvring has taken place.

Fig. 44 – Potential Firing Point – 12 October 2022

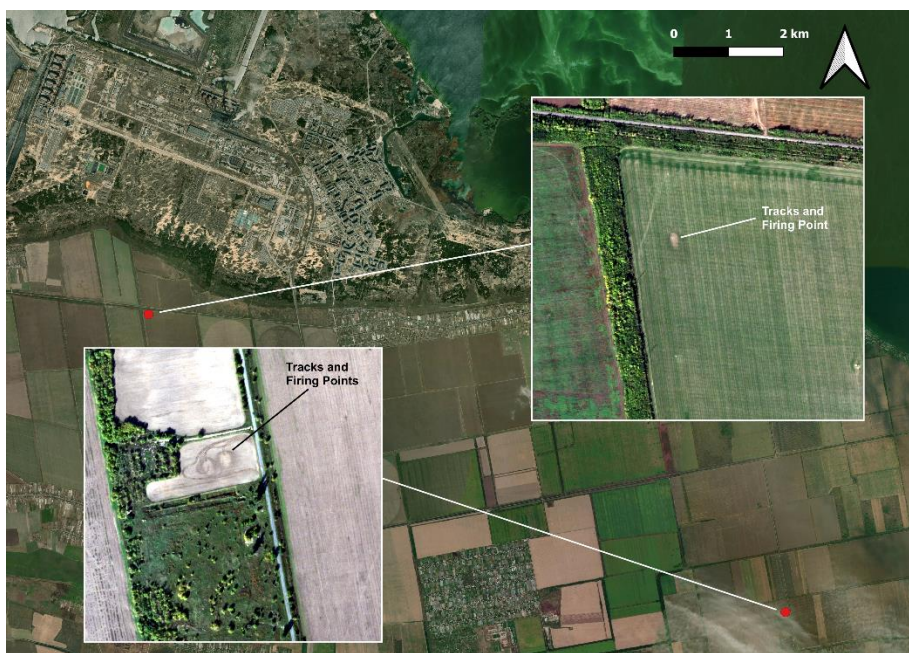
Fig. 45 – Potential Firing Point – 15 October 2022

Two likely firing positions were identified at two separate locations to the southeast of the plant (Fig.45). The closest of the two positions was identified on imagery dated 15 October 2022 but will have been occupied between 19-15 October 2022. The tracks are very faint but are discernible. But a large ground scarring suggests that a firing of a likely MRL occurred at this location. The second location was further from the plant and indicates at least two vehicles had entered a small field and performed significant manoeuvring, most likely to position for a fire mission.

Coordinates – 47.47307, 34.60867 and 47.42467, 34.76314.

Distance from ZNPP – 4.3km and 16.2km southeast of the plant.

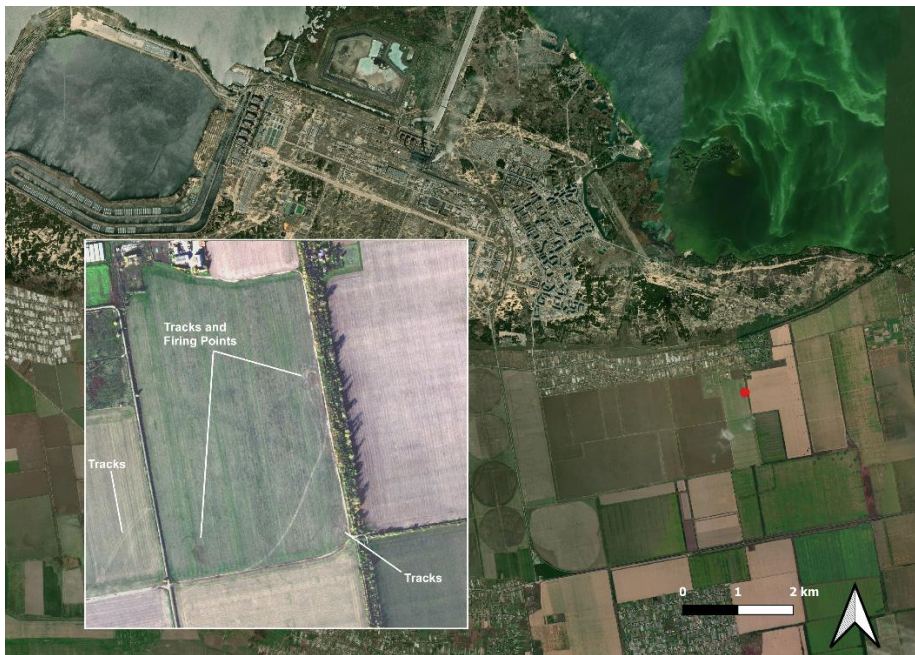
A possible firing position was identified on imagery dated 5 November 2022 to the east of the plant indicating use by artillery assets between 8 October and 5 November 2022 (Fig.46). The track observed suggests a vehicle or vehicles entering the field then cutting the corner before manoeuvring into a position along the eastern edge of the field.

Fig. 46 – Potential Firing Point – 5 November 2022

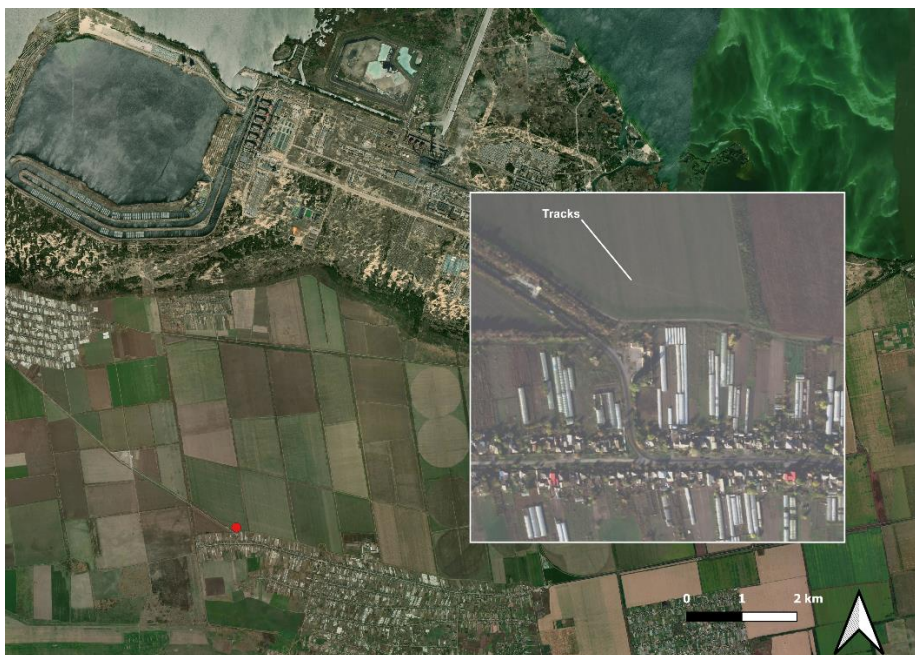
Fig. 47 – Potential Firing Point – 7 November 2022

A track was identified on imagery dated 7 November 2022 leading to a possible firing point (Fig.47). The track enters the field at the southeastern corner then moves along the southern edge before indicating vehicle manoeuvring. The tracks were made at some point between 1 and 7 November 2022.

Coordinates – 47.44635, 34.58071.

Distance from ZNPP – 6.8km south of the plant.

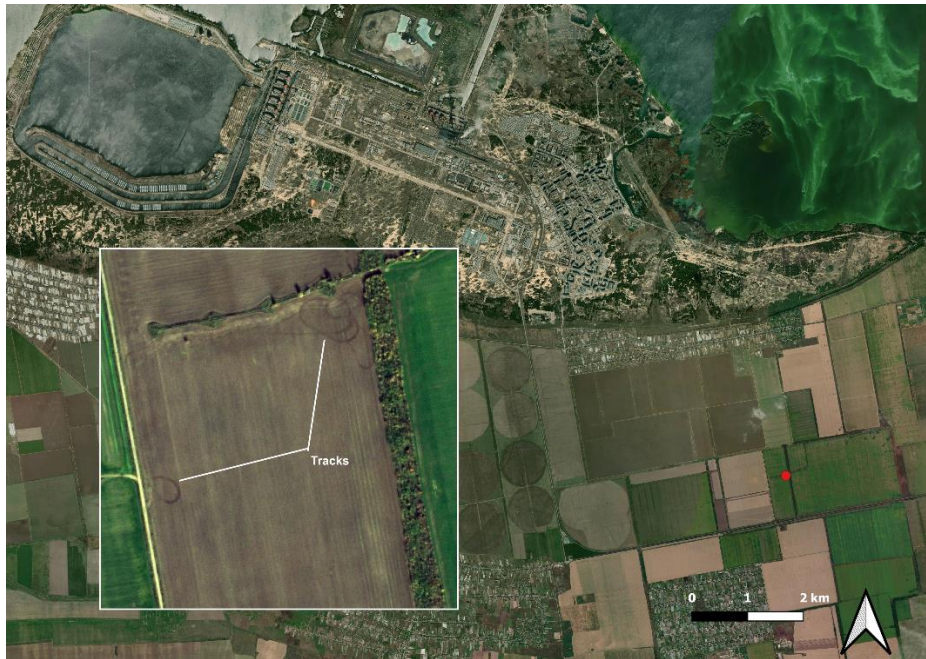
A number of tracks were identified on imagery dated 14 November 2022 (Fig.48). The tracks were observed at two different positions within the field with evidence of vehicle manoeuvring at both positions, at the western edge and northeastern corner. It was not possible to assess a date range for the activity as no previous imagery of the position was available.

Fig. 48 – Potential Firing Point – 14 November 2022

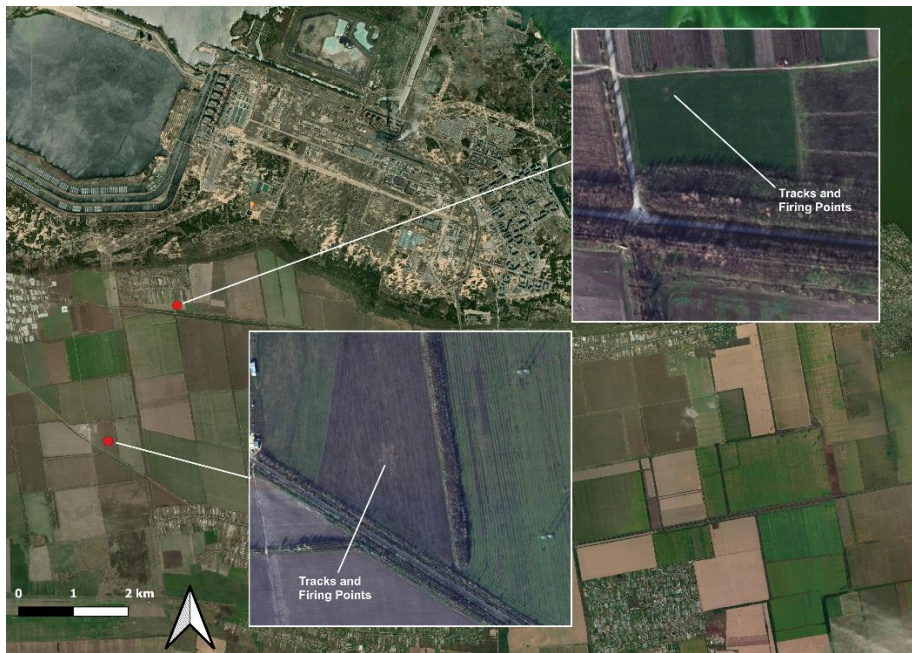
Fig. 49 – Potential Firing Point – 4 December 2022

Two likely firing positions were identified on imagery dated 4 December 2022 at two separate locations to the south of the plant (Fig.49). The closest of the two positions occurred at some point between 15 November and 4 December 2022. The tracks are not very clear but two scars on the ground suggest a recent firing of an MRL at that position. The furthest position displays evidence of possible vehicle manoeuvring in a field adjacent to a road at a point between 15 November and 4 December 2022.

Coordinates – 47.47829, 34.57613 and 47.45637, 34.55995.

Distance from ZNPP – 3.4km and 6km south of the plant.

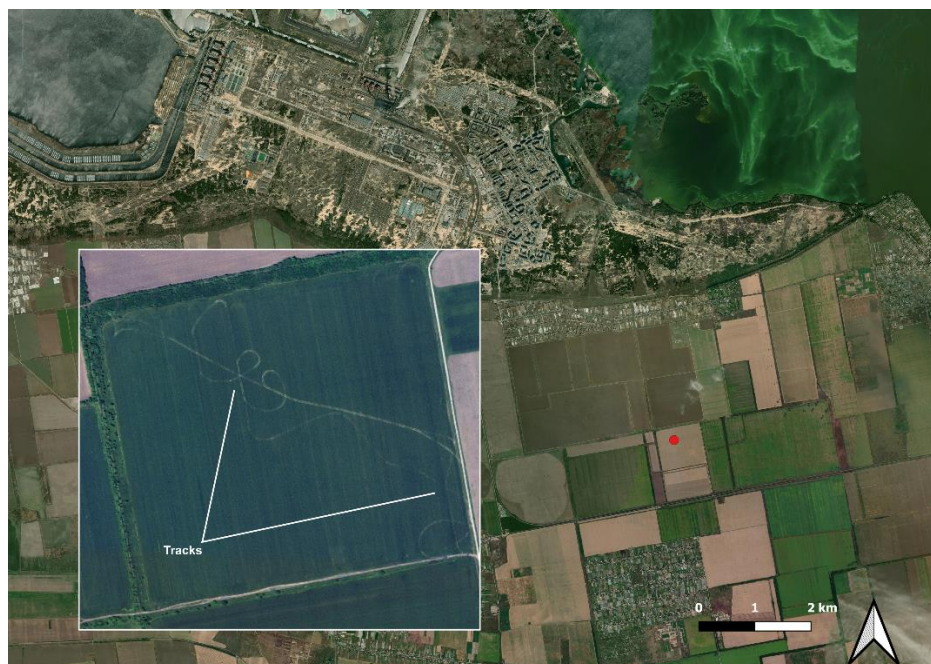
Fig. 50 – Potential Firing Point – 28 May 2023

Coordinates – 47.45240, 34.69537.

Distance from ZNPP – 10.3km southeast of the plant.

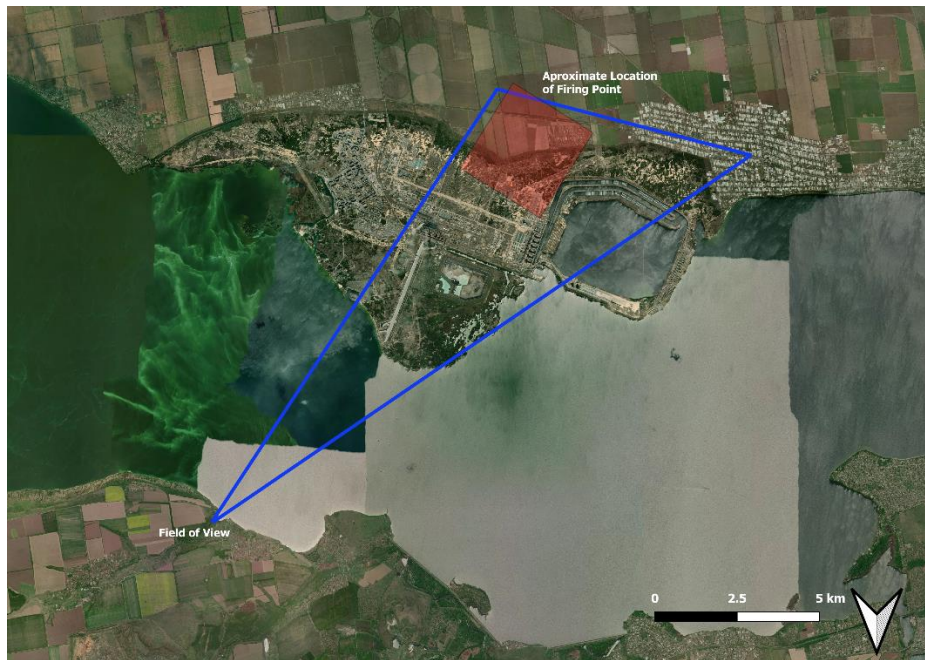
Fig. 52 – Field of View and Assessed Location of Firing Point

With the field of view calculated, the next step was to identify the likely location of the firing point. From the field of view, using the ZTPP and ZNPP as reference points, the direction and relative position of the firing point of the rockets observed in the video was assessed and an approximate area of the firing point was calculated as illustrated by the area shaded red in Fig.52. As there is only a single point of view, it was not possible to triangulate the position. When compared to the analysis conducted to identify the firing points, there were a number of firing points identified within this area from the beginning of September 2022. This area was identified as a preferred firing position in the analysis and is easily accessible to any system that has been reportedly based in the town of Vodyanoye.

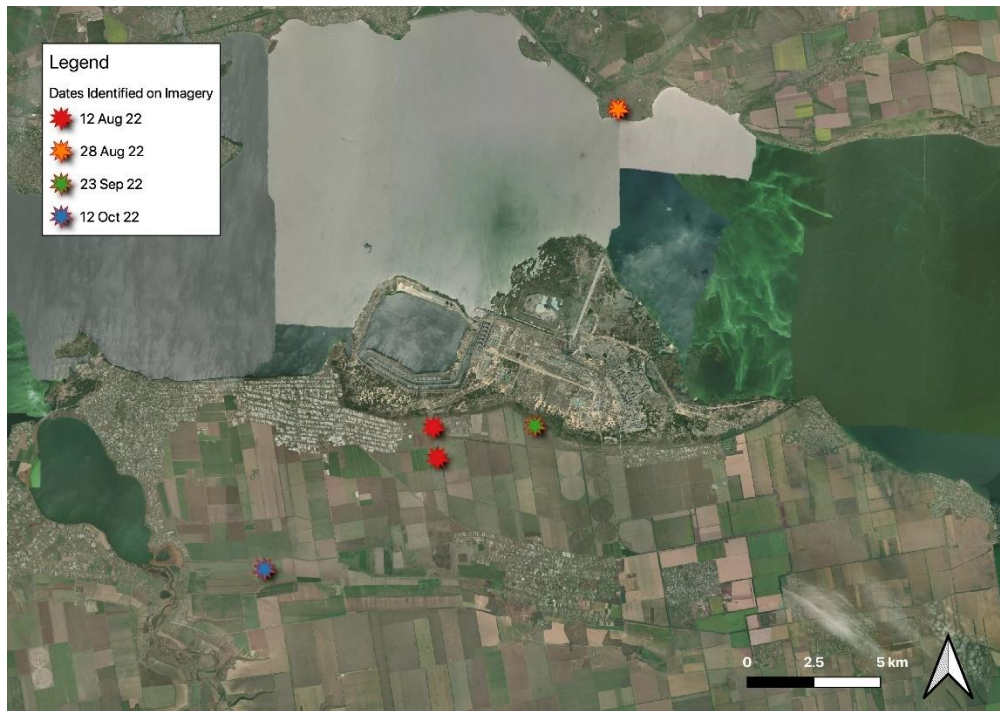
Fig. 53 – Map of Impact Points Identified on Imagery

The wider area study also identified instances of incoming fire around the plant with impact points appearing on imagery (Fig. 53). Analysis of the impact point crater can identify the general direction of flight of the rounds. The trajectory of falling artillery and mortar rounds are rarely from directly above. The resulting crater from the impact tends to have a larger displacement of earth on the opposite side from the firing point of the round and can identify the likely direction of flight of the rounds.

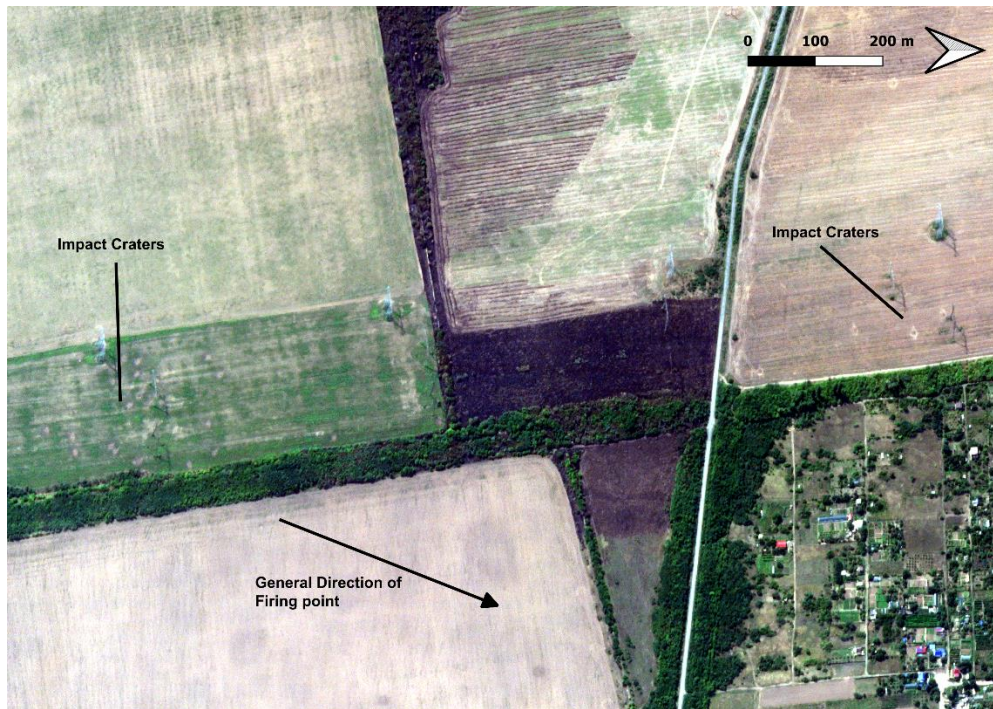
Fig. 54 – Impact Craters 12 August 2023

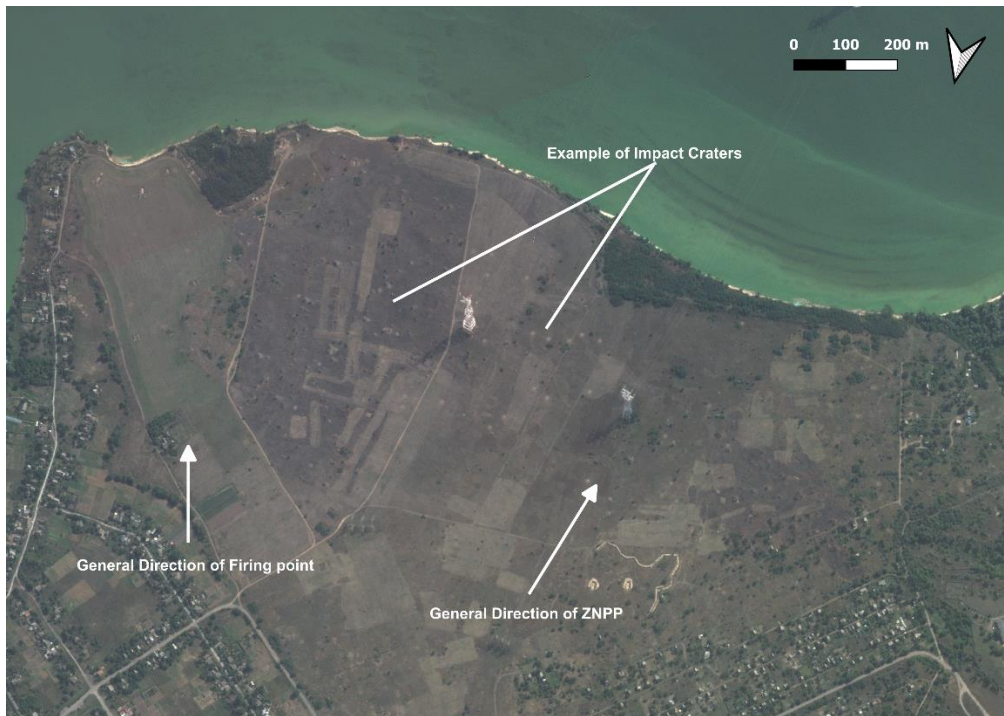
Fig. 55 – Impact Craters on Dnipro Peninsula 28 August 2023

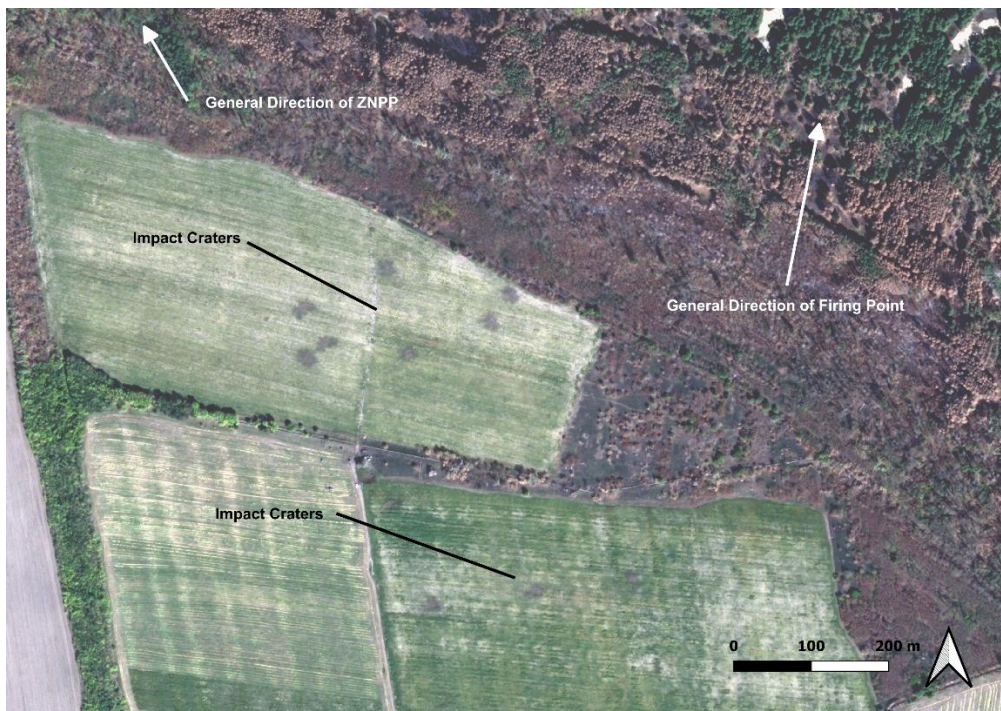
Fig. 56 – Impact Craters 23 September 2023
